Church of St Edmund, Castleton: Derbyshire

Post-Reformation Wall Paintings

Conservation Report

Rickerby & Shekede
May 2024

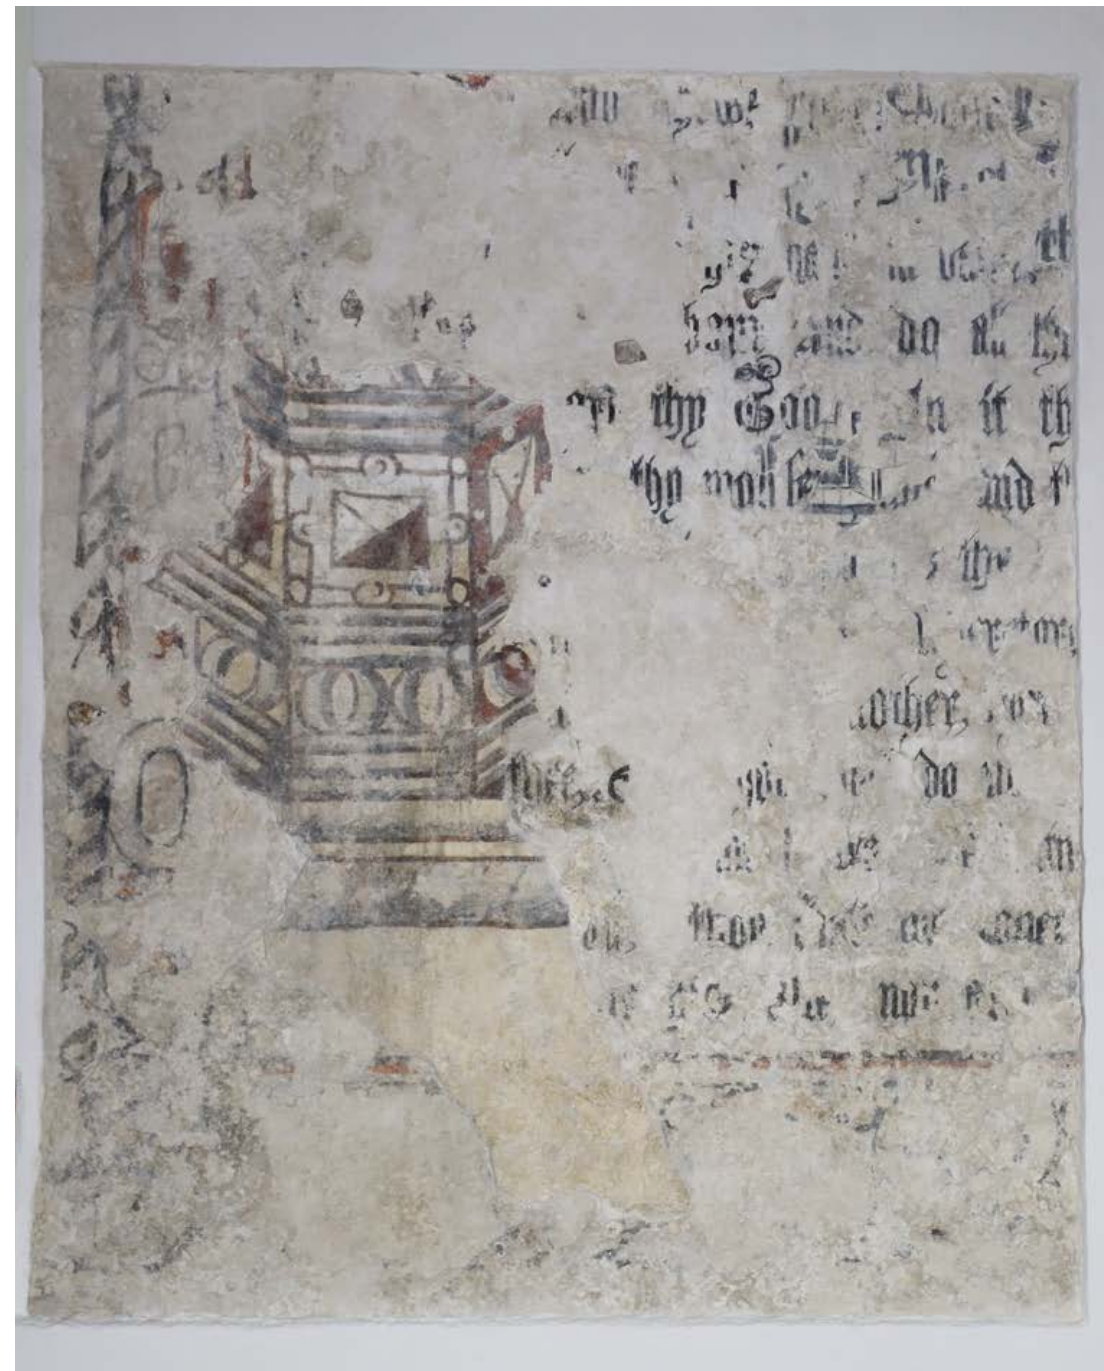
Above: The post-Reformation painting now revealed at the east end of the nave south wall.

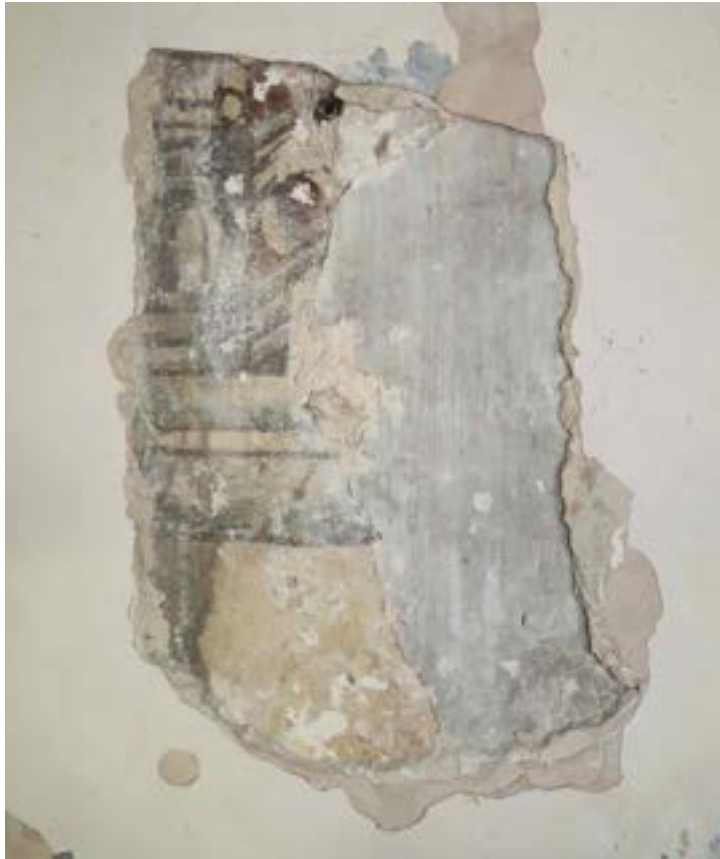
Above: The fragment of wall painting before its uncovering and treatment. Collapse of the covering plaster in around 2012 led to its unexpected exposure.

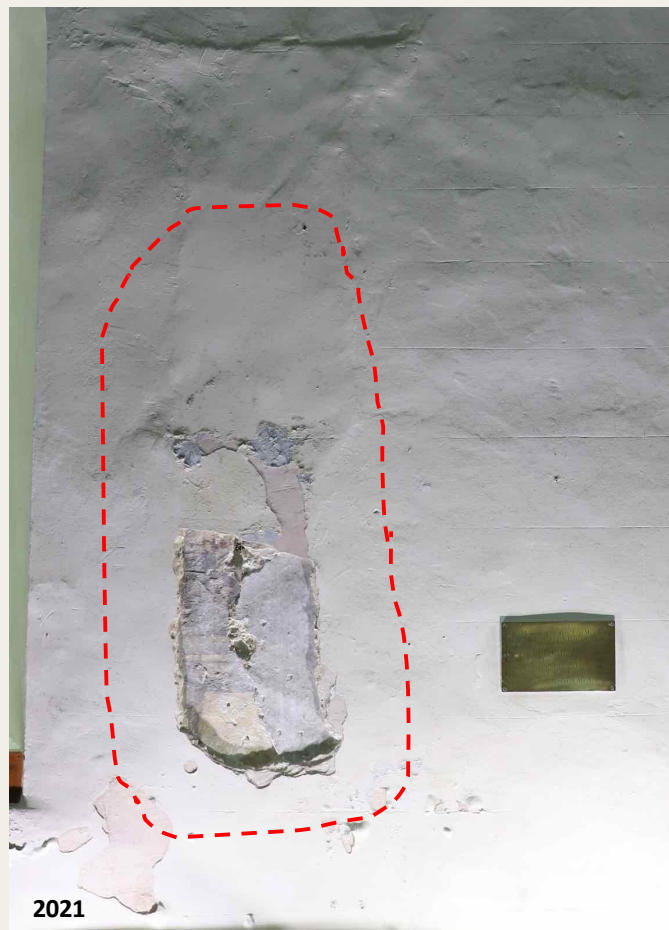
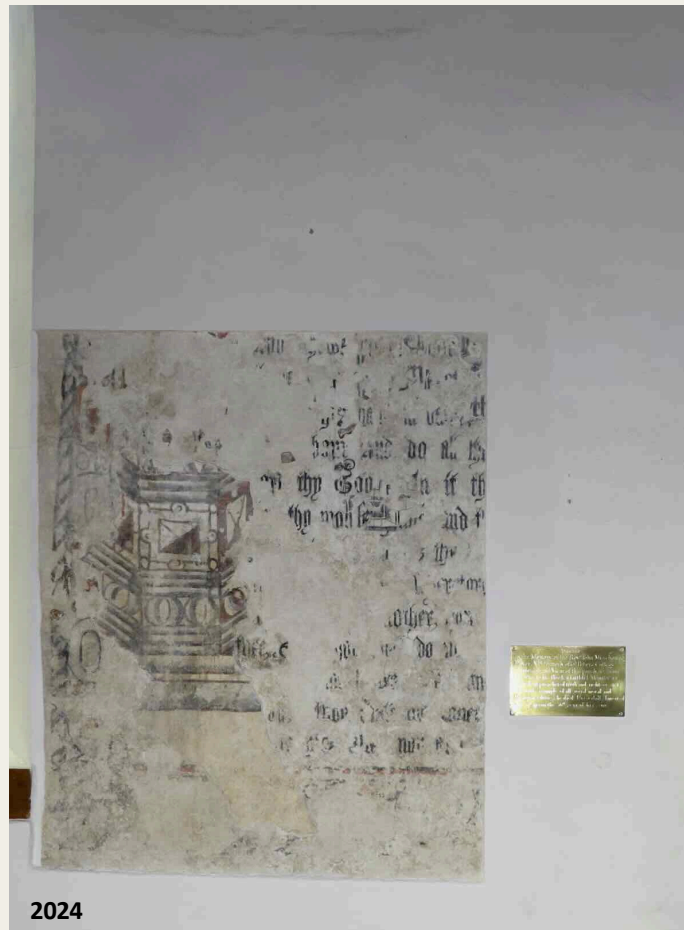
Left: The dashed line in the raking light image (far left) was an estimation of the extent of painting that remained concealed, based on the evidence of small uncovering 'windows' made in the vicinity of the fragment in 2021. Expectations were exceeded, as shown by the comparison image of the painting after its uncovering (near left). Moreover, this represents less than half the extent of the original painting (see page 25), with more concealed painting surviving above and to the right of that which is now revealed.

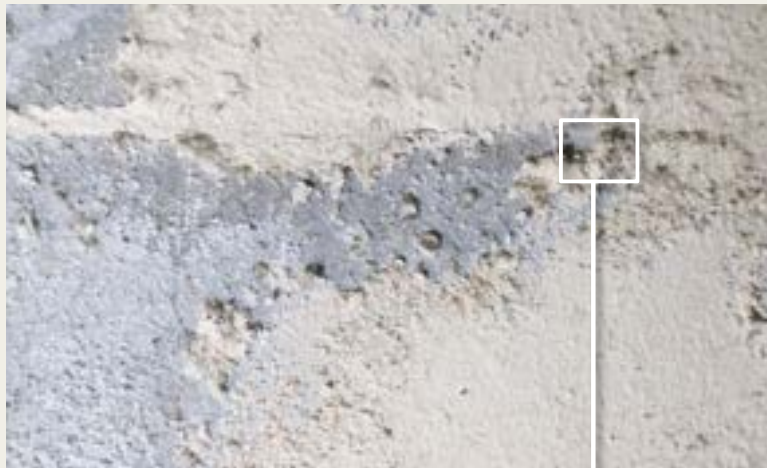
The findings of the 2021 investigations provided important insights of the condition of the painting fragment and its principal deterioration risks, helping to determine treatment options.

Although damaged and fragmentary, the painting was found to survive in generally excellent condition, with no serious signs of powdering plaster or flaking paint, for example. Nor was there evidence of inherent salt-related deterioration associated with the original plaster materials. However, soluble ions from surrounding non-original plasters and repairs (cement and gypsum-based materials) had caused salt damage. Analysis indicated that these were sources of sulfates. Many sulfate salts – such as calcium sulfate (gypsum) and the sodium sulfates, thenardite and mirabilite – are highly damaging. They cause disruptive sub-surface expansion pressures upon crystallization [Matteini 1990: 140-142].

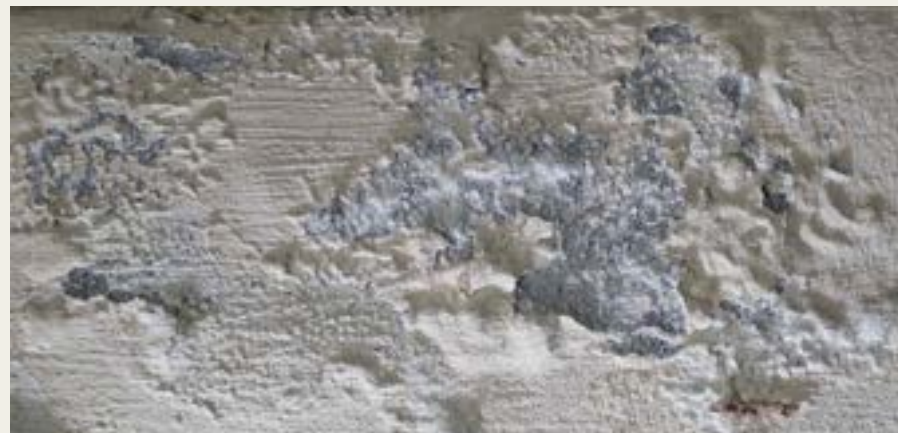
Above: The salt activity associated with the plasters and repairs overlapping and surrounding the painting was consistent with expansive and highly disruptive sulfates.

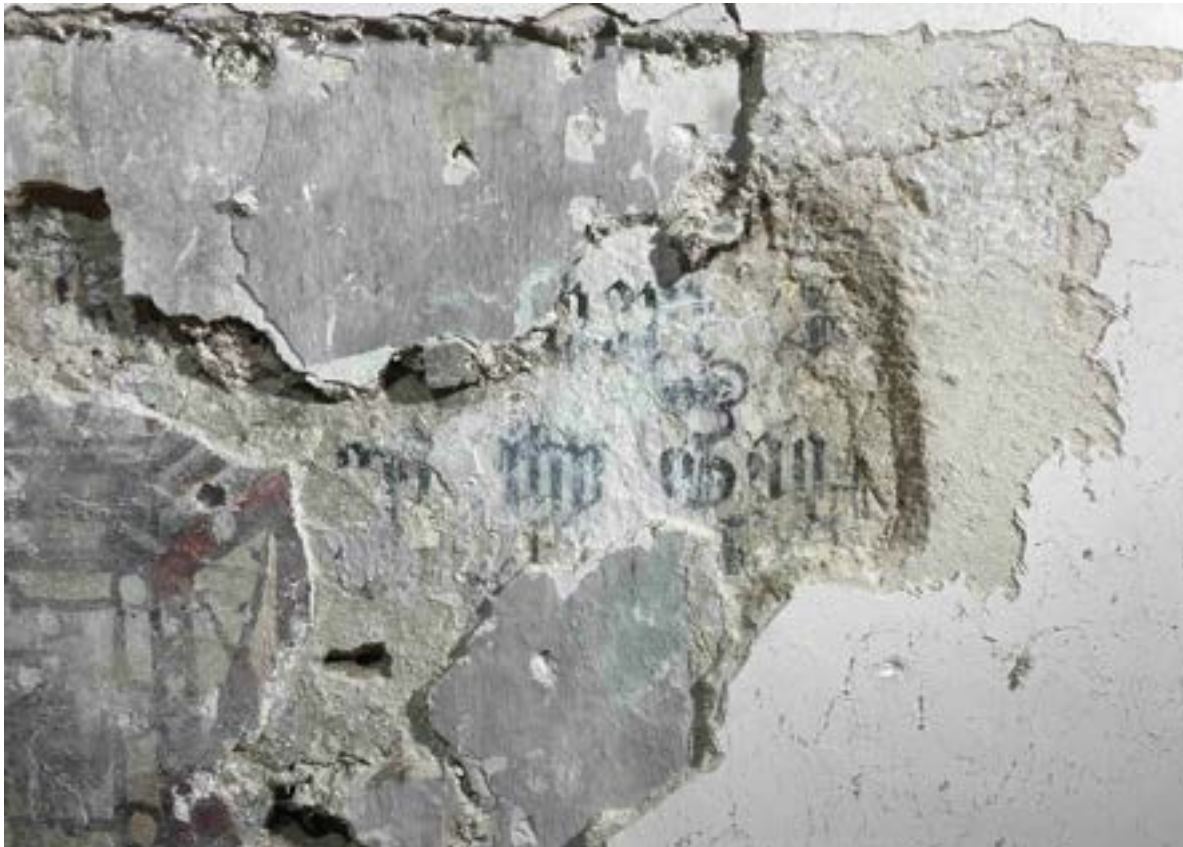
Left: Detail of the painting at the beginning of its uncovering and treatment.

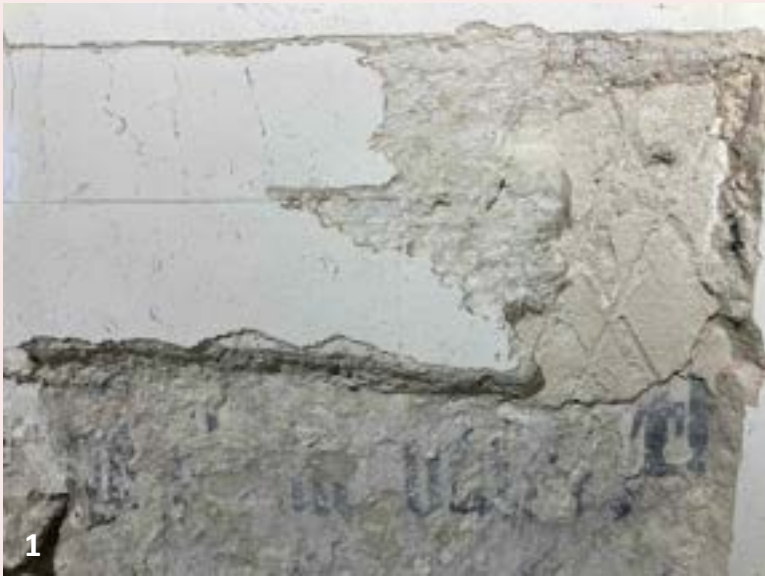
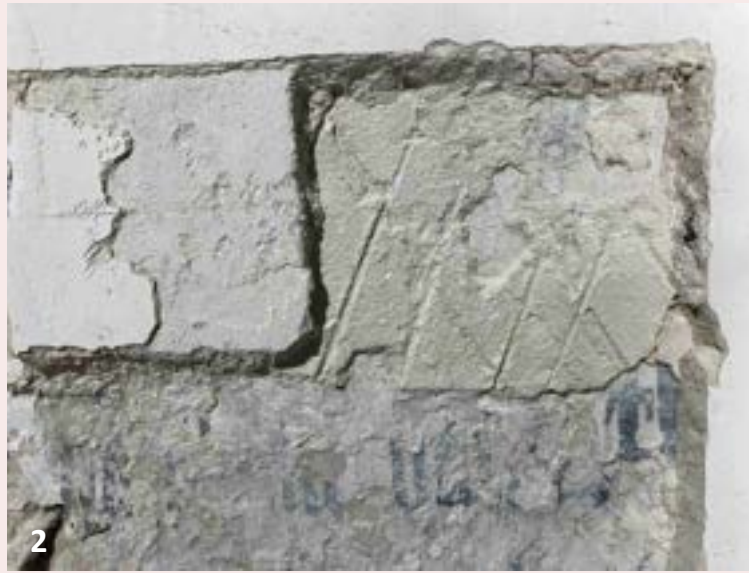
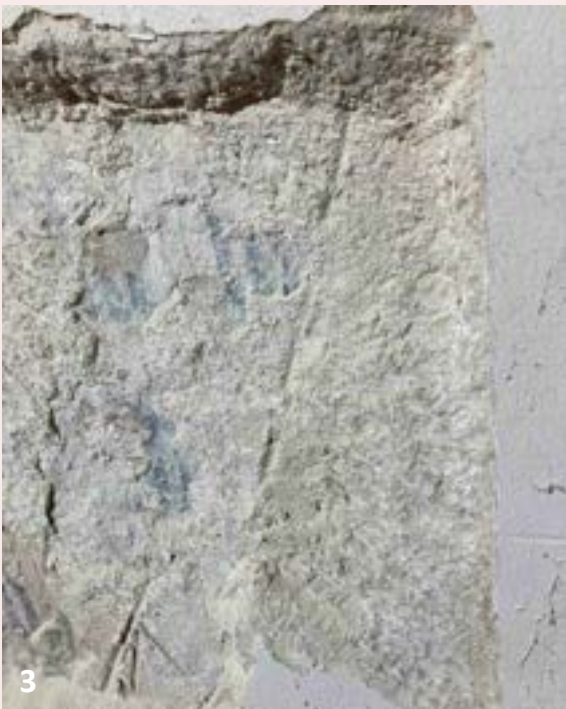
Left: Stages in uncovering of the painting from beneath the C19 plaster: (1) initial chiseling of overlying plaster, revealing its application in two layers, the lower one scored to receive the upper layer; (2) gradual uncovering and thinning of overlying materials, layer by layer; (3) thinning of remaining covering material; and (4) after uncovering.

Uncovering can be a damaging process, especially if historic (and generally weaker) layers are concealed beneath stronger and well-bonded covering layers. Circumstances at Castleton proved fortuitous, however. Firstly, the historic phases of painting survive in generally good condition and are themselves well-bonded to their substrate materials. Unusually too, the revealed painting is not generally composed of multiple layers, which typically tend to shear at interfaces. For example, the text painting for the most part is executed on a limewash layer that was applied directly over the stone, which encouraged good adherence. Although the 'architectural' fragment is superimposed over the text painting, it is executed on a single, coherent plaster layer. Some of the the later (unpainted) covering layers were already separated and were therefore easily removed without risk. The C19 plasterwork, on the other hand, was firmly bonded to the underlying painting. However, its thickness and aggregate-rich composition allowed it to be gently pulverized by mechanical means, which usually disintegrated the plaster rather than separated it by shearing.

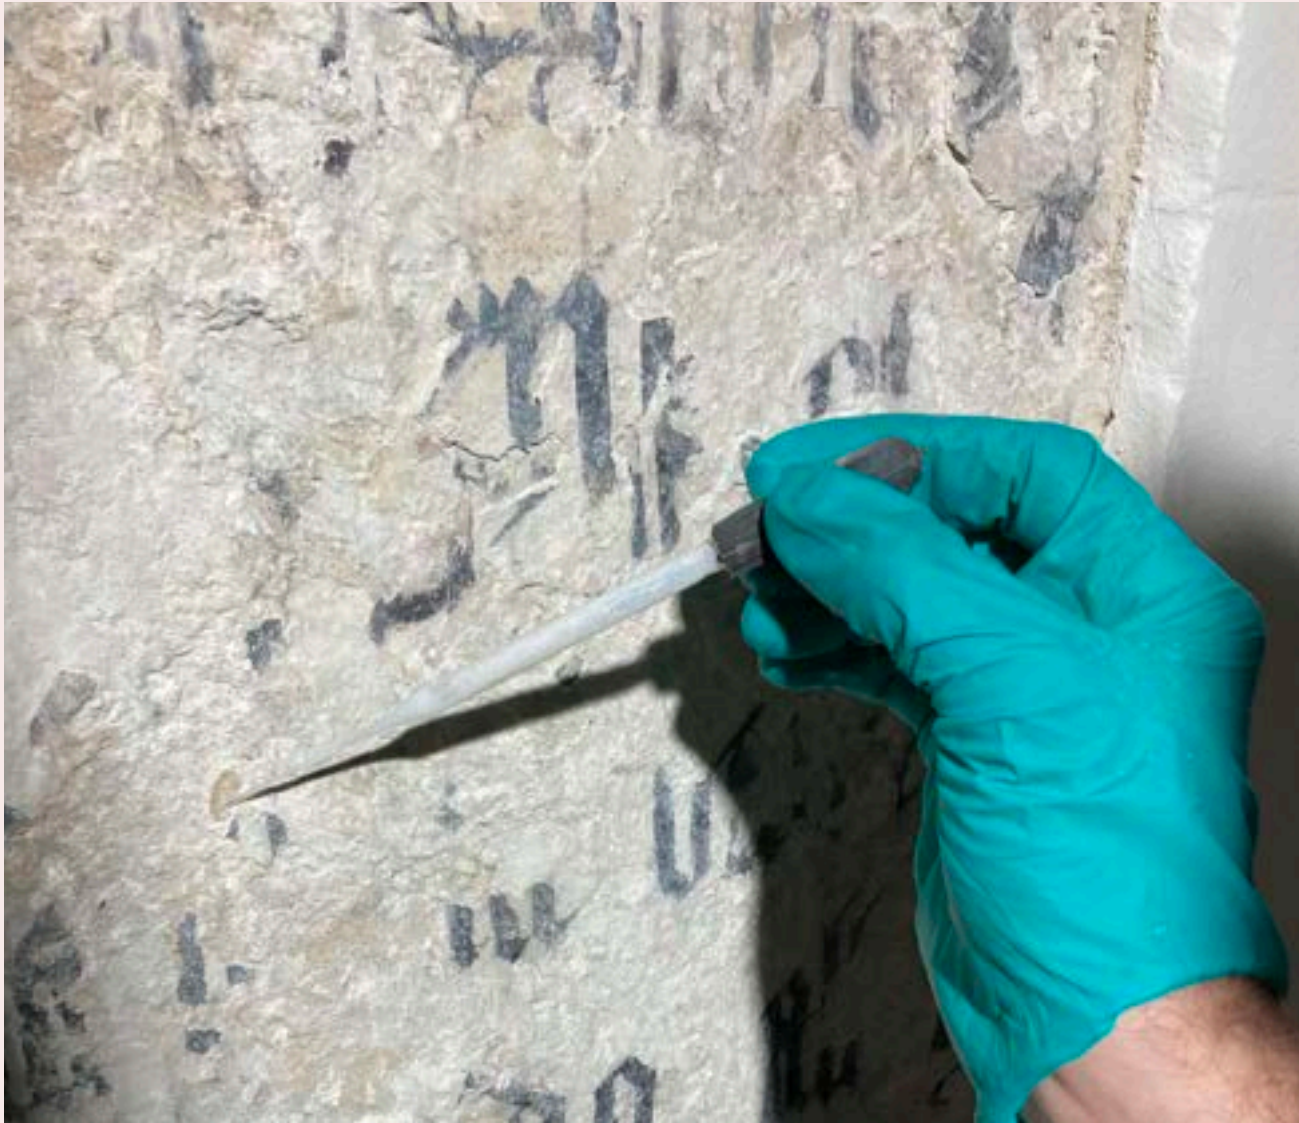
Above: Nano-lime consolidation.

A nano-lime dispersed in alcohol (CaloSil® E50) was used as the consolidant. Colloidal dispersions of $\text{Ca}(\text{OH})_2$ nanoparticles offer a number of advantages: as a lime-based system, compatibility with the original plaster and limewash materials is maintained; proven efficacy in limiting carbonation of the nano-lime particles by CO_2 before they have been deposited in the substrate; appropriate penetration depth, strength, hardness, surface cohesion, capillary absorption, etc.; and little or no change of internal pore structures, so that effective porosity is maintained in the original materials. Nano-limes have been widely studied and verified in terms of their stability, and performance and working properties.

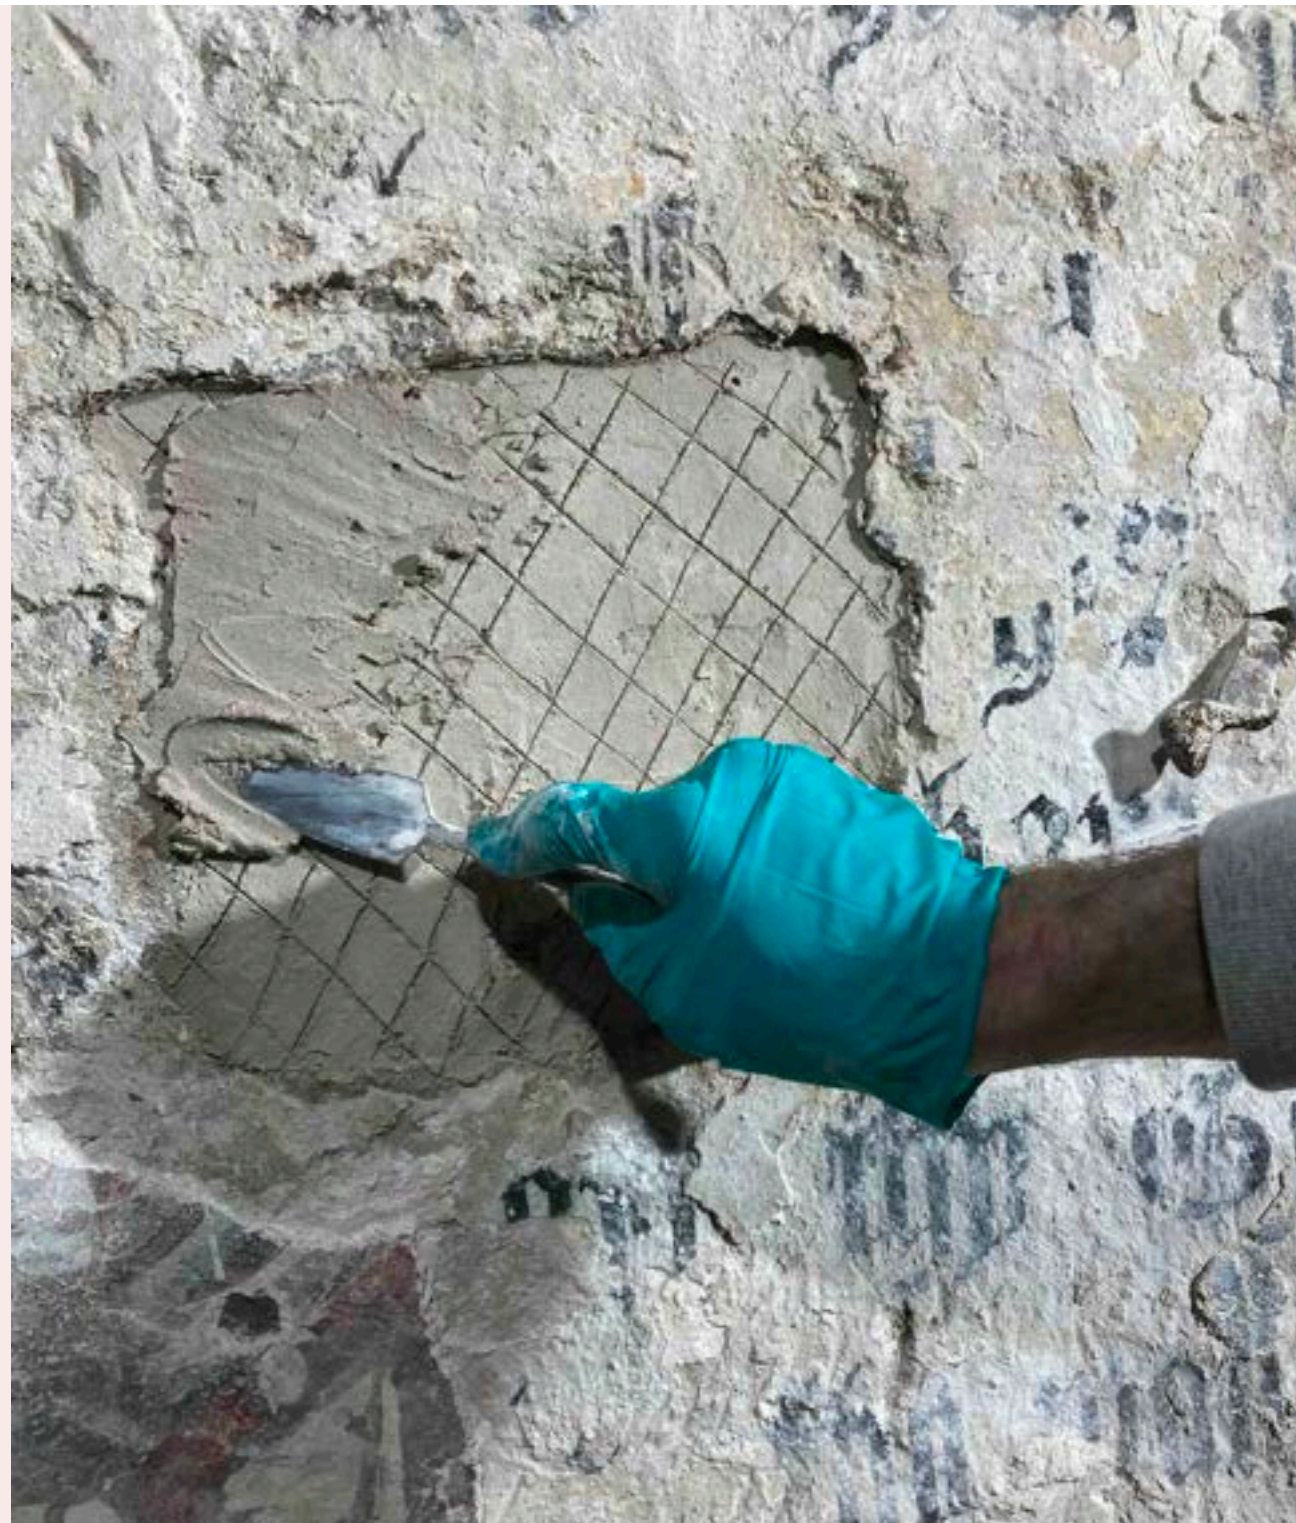
Right: building up layers of the coarse plaster over a put-log hole.

Two types of repair were formulated for the painting: a coarse plaster for deep fills and a fine plaster for shallow, upper-level fills. Uncovering revealed a number of deep put-log holes which had been blocked with stones, usually quite randomly and poorly. Unstable and heavy stones were removed and either replaced or reinserted along with smaller stones, to achieve more stable packing. The coarse plaster was then built up in layers over the stone base. This comprised 1 part lime, 4 parts sharp sand (v/v). The fine plaster was used for the many shallow losses and for skimming over the deep fills. This was formulated with a chalk powder component to give it a smoother surface texture, to better match the exposed layers at and just below the surface of the painting (1 part lime, 2 parts play-pit sand, 1 part chalk powder, v/v).

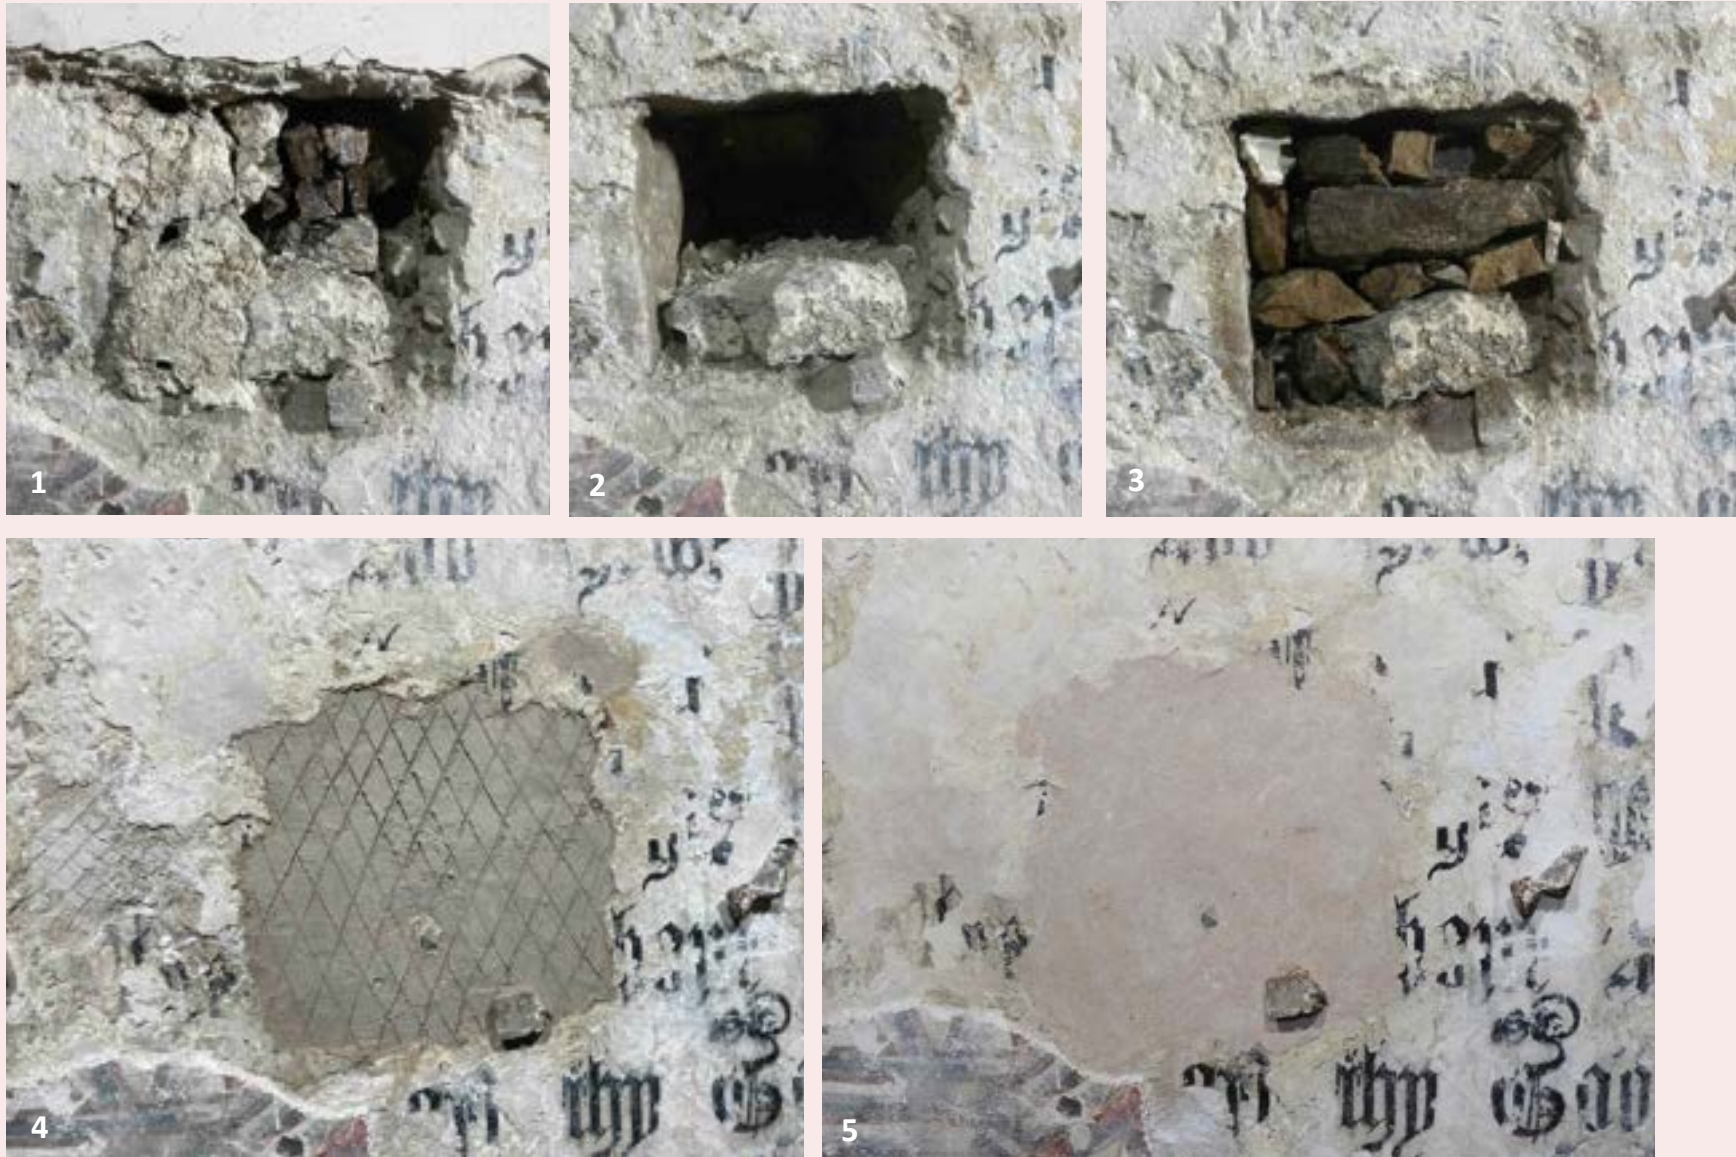
Above: Stages in making repairs: (1) put-log hole randomly filled with stone pieces and wood, as found after uncovering; (2) during removal of loose filling materials; (3) reinsertion and packing of filling materials and pre-wetting; (4) after application of lower coarse plaster; and (5) after application of upper fine plaster.

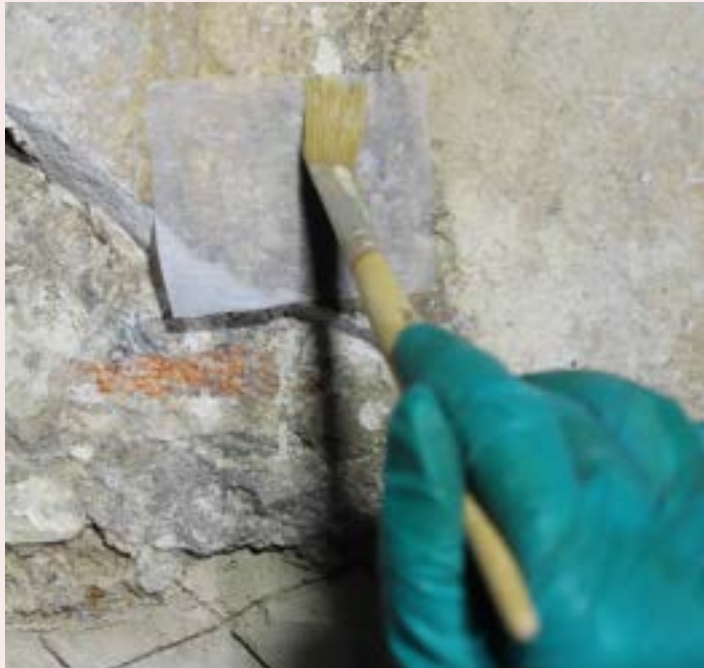
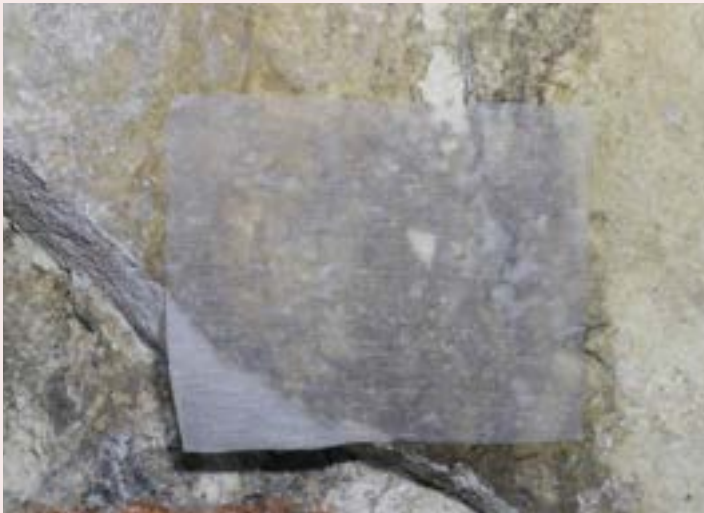
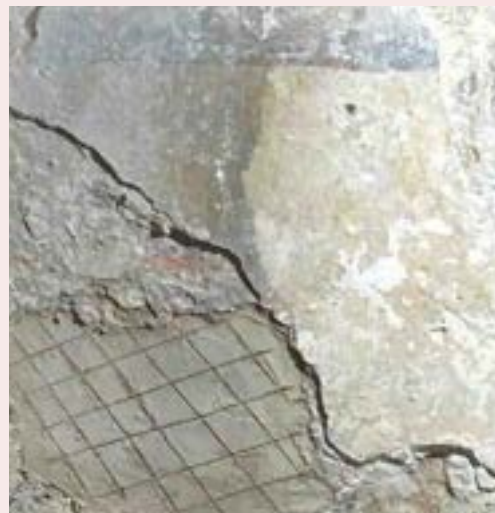
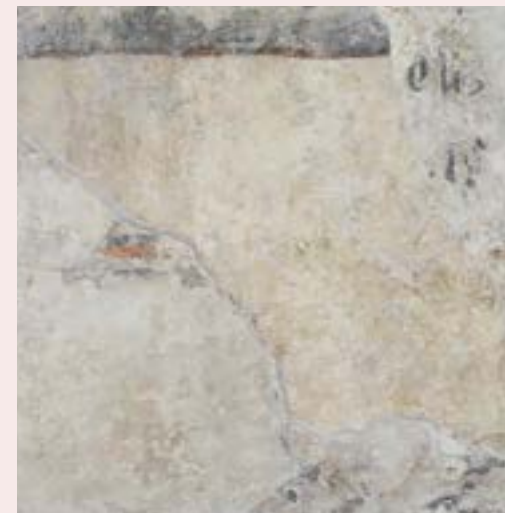
*Left: Cleaning with ammonium bicarbonate through a sorbent layer to reduce intransigent staining.
Below: Before (left) and after (right) cleaning.*

Although dirt deposition on the painting was not a major problem, different cleaning procedures were adopted for different problems. Unbonded dust and debris were easily removed with soft brushes and air puffers. Slightly bonded dirt was cleaned with specialist sponges and water. A melamine sponge (Meleco®) with an open-cell, slightly rigid structure consisting of slender webs – which makes it mildly abrasive, yet capable of yielding rather than damaging the paint surface – was used to dislodge dirt and trap it in the open spaces between the strands. A PVF sponge (Saugwunder® suction-block) was used for rinsing and clearance. This is classed as a super-absorbent sponge due to its capillary structure, which is capable of easily absorbing and retaining excess moisture during clearance. Its smooth surface also makes it ideal for use on paintings. An area of intransigent staining on the lower part of the 'architectural' fragment was cleaned using ammonium carbonate (15% solution) applied in sorbent layers, followed by clearance.

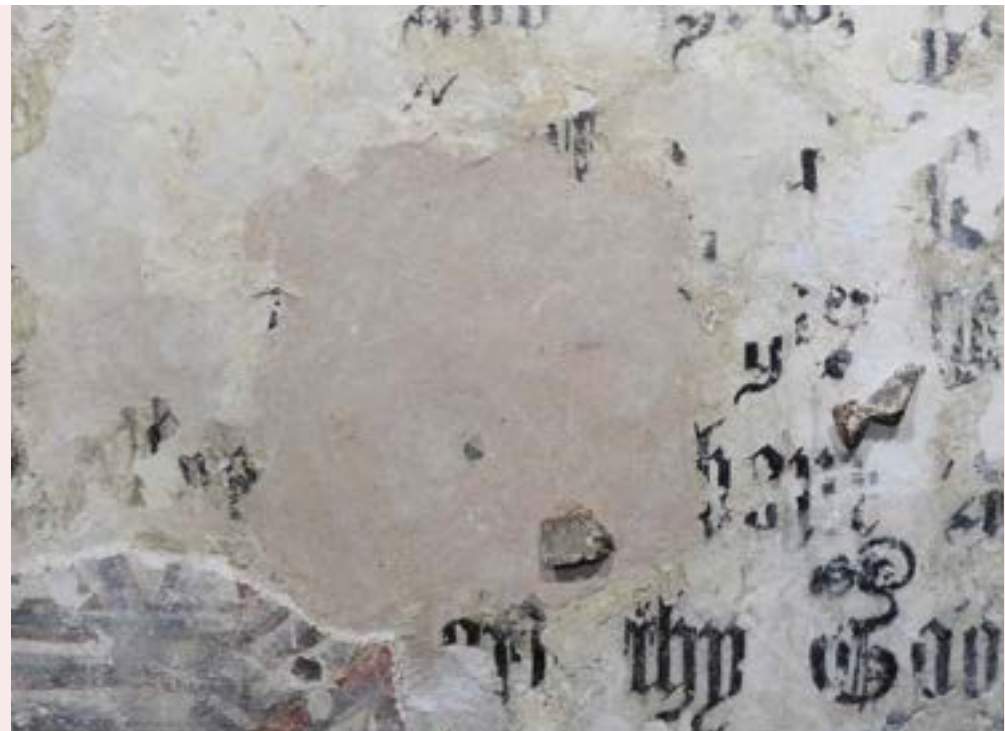
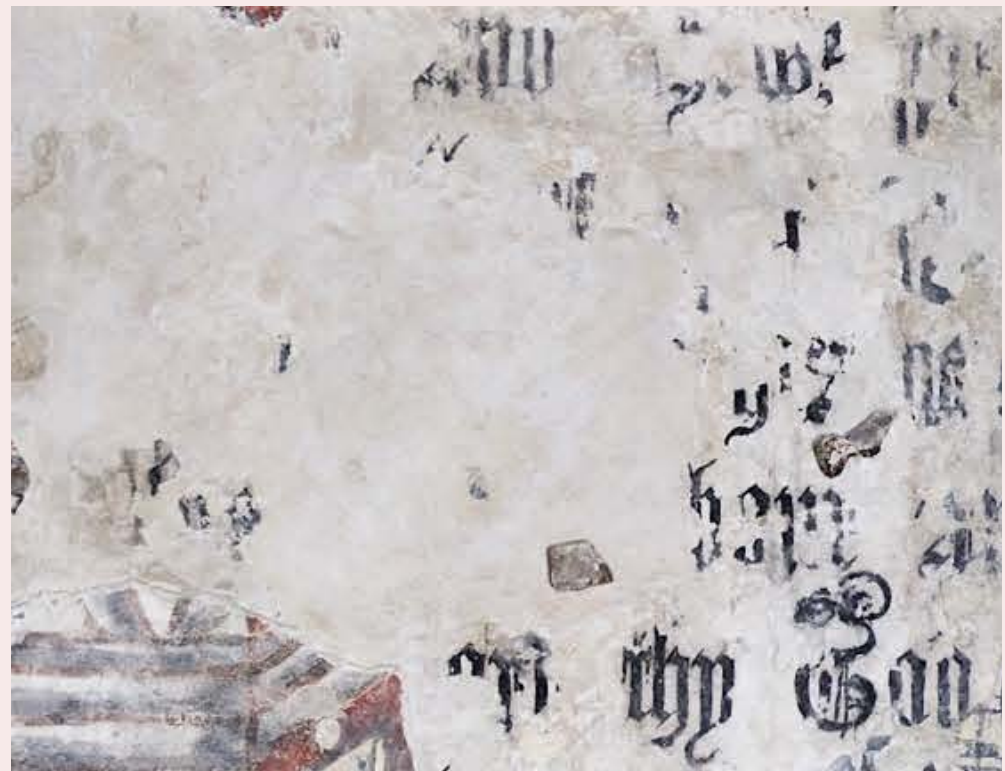
Right: new fills (top) were limewashed and toned with watercolours (limited to dilute mixtures of raw umber and black) to make them merge into the background (bottom).

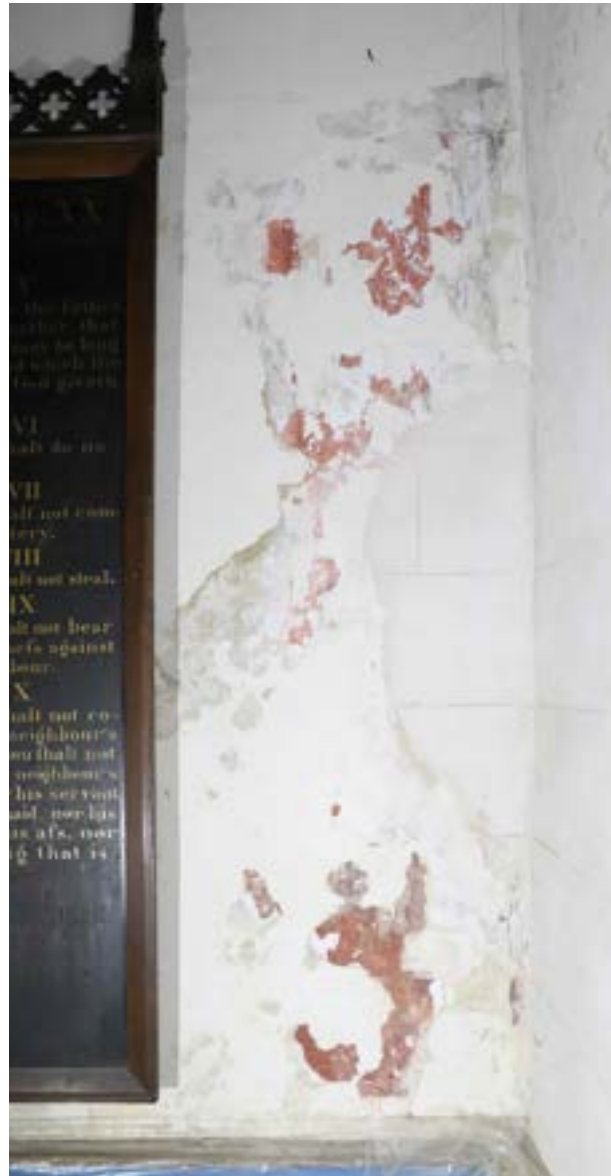
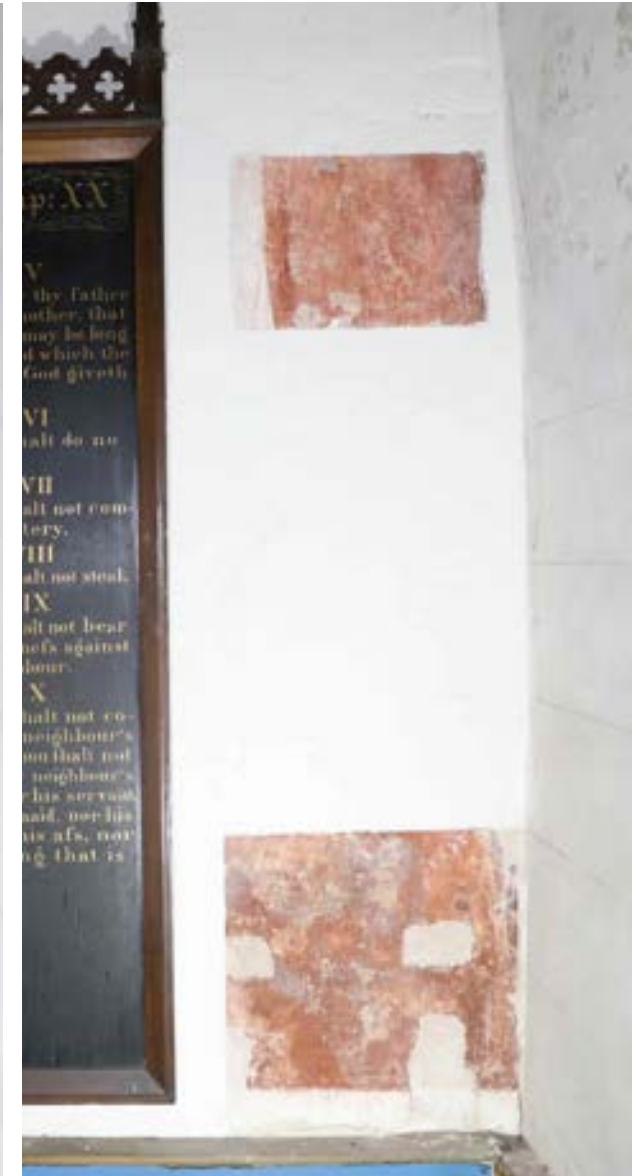
Right: The remains of red painting on the north side of the west wall before (left) and after (right) its protective re-covering and selective uncovering.

For the re-covering of the painting, a layer of chalk powder suspended in industrial methylated spirit (IMS) was first applied as an inert protective layer. Over this, limewash was then applied in successive layers.

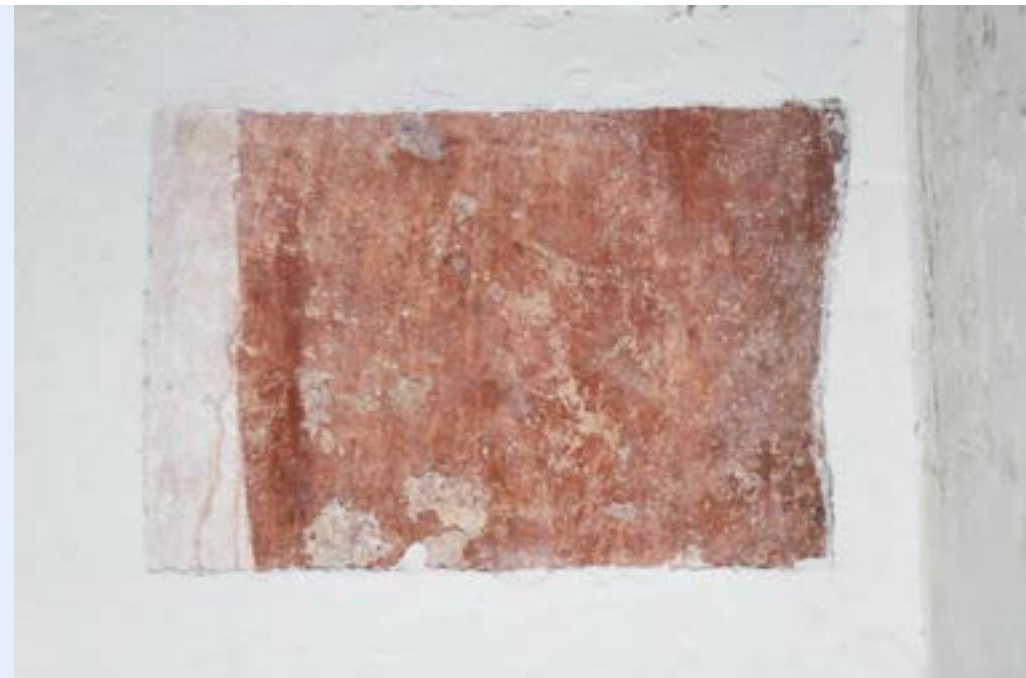
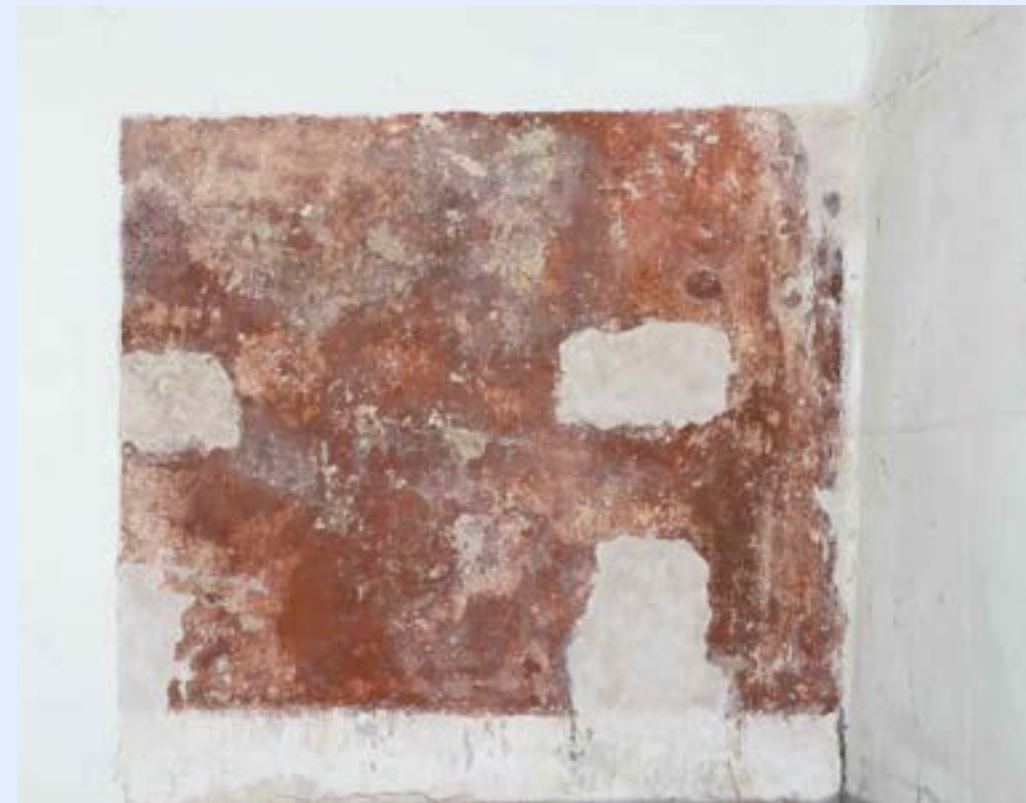
Right: Details of the upper and lower uncovering 'windows' on the north side of the west wall.
