Church of St Edmund, Castleton: Derbyshire

Post-Reformation Wall Paintings

Conservation Report

Rickerby & Shekede
May 2024

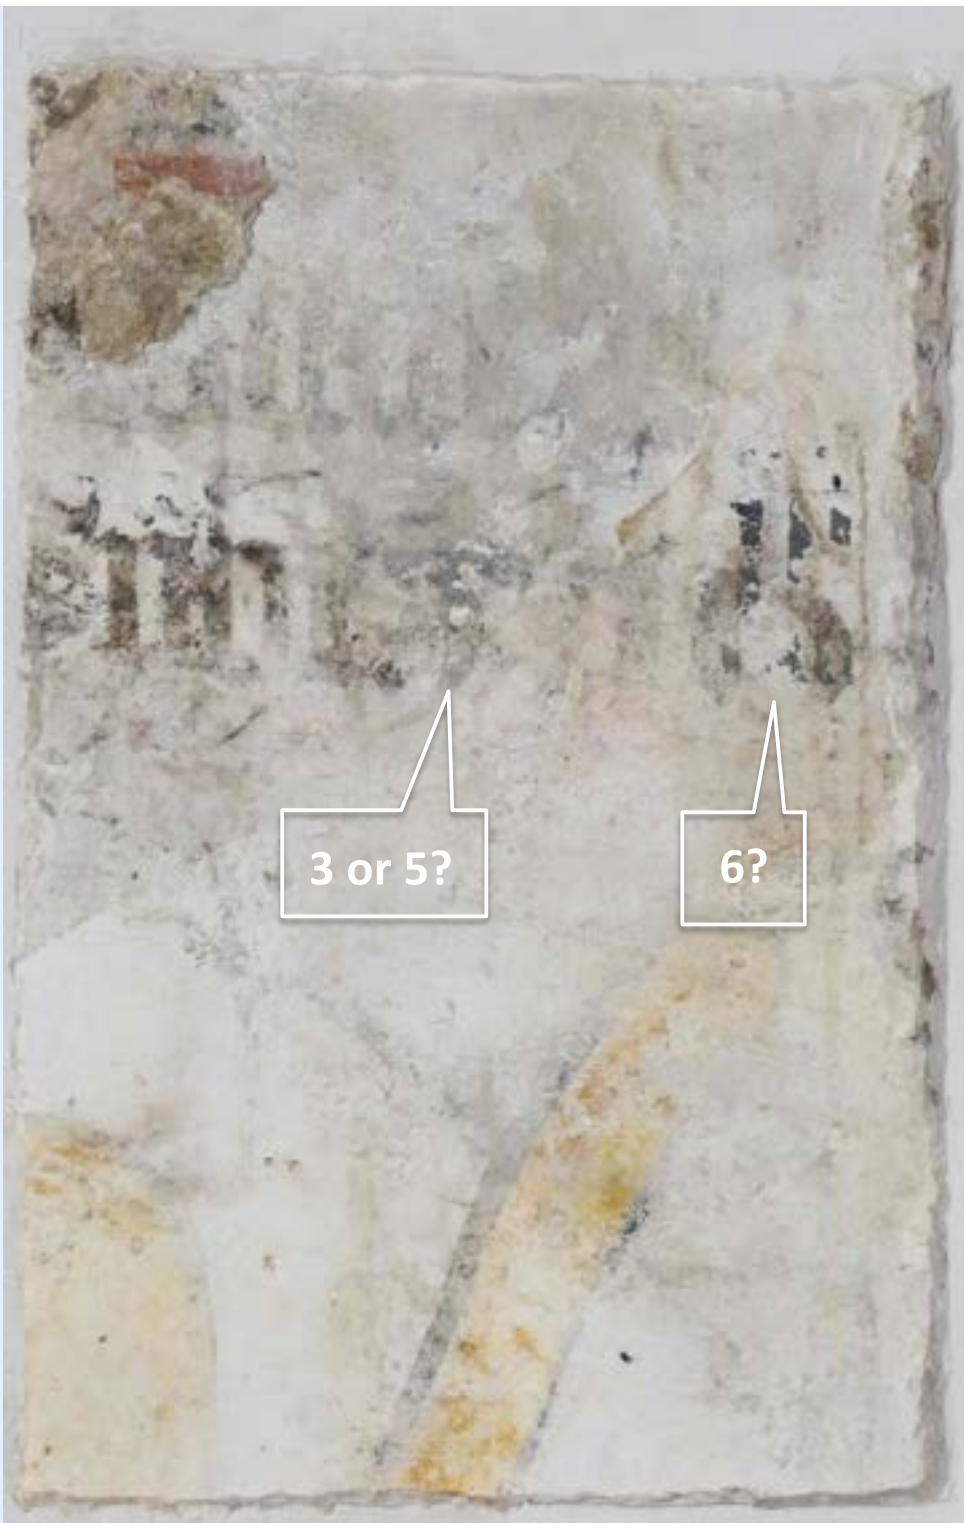
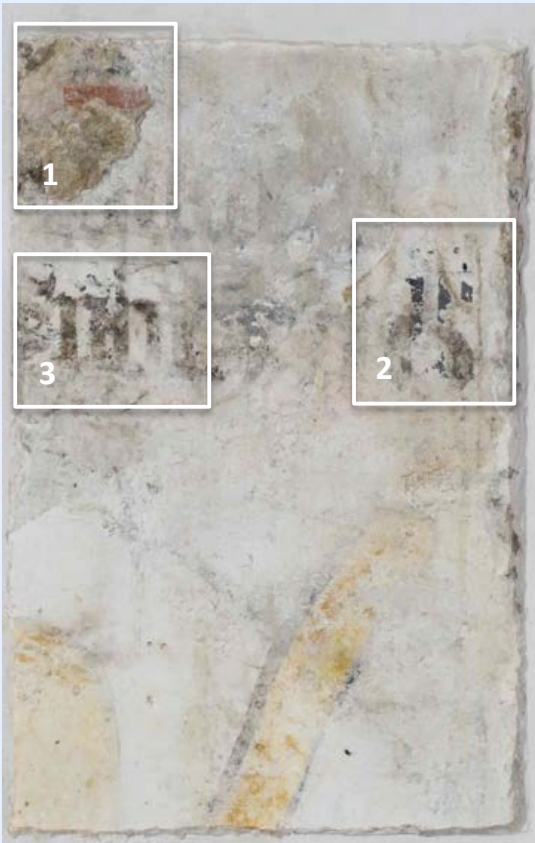
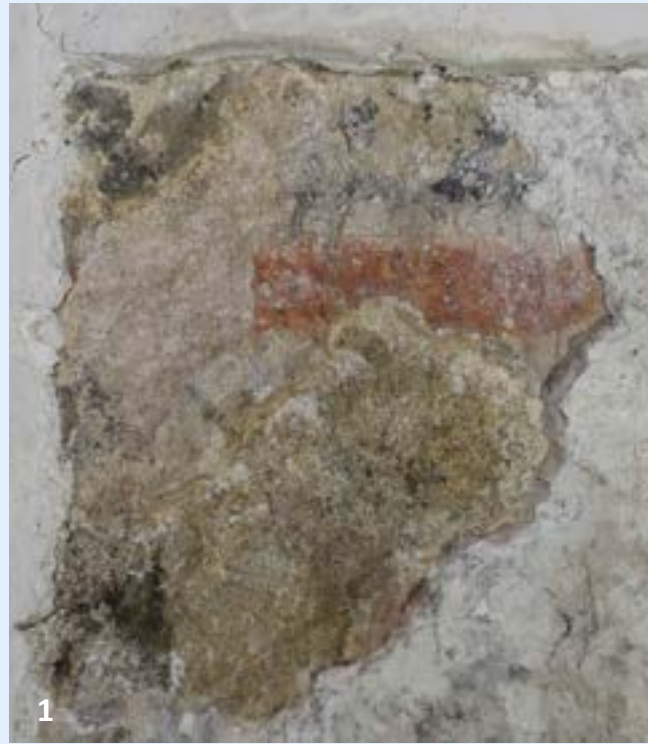
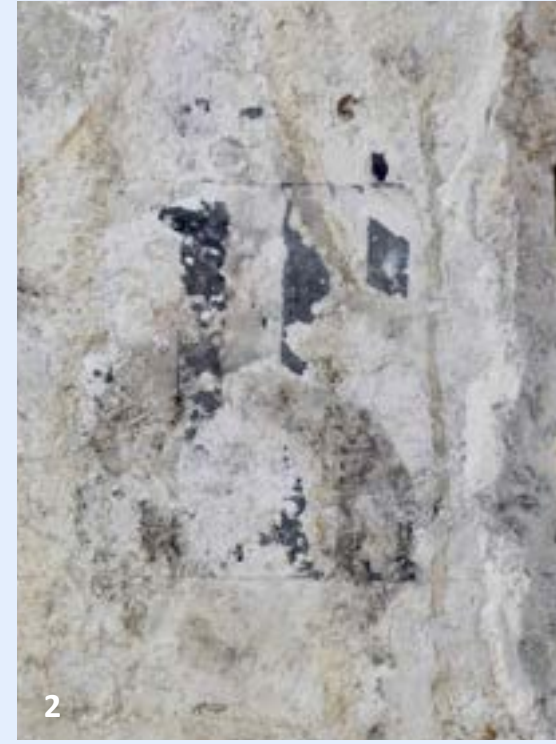
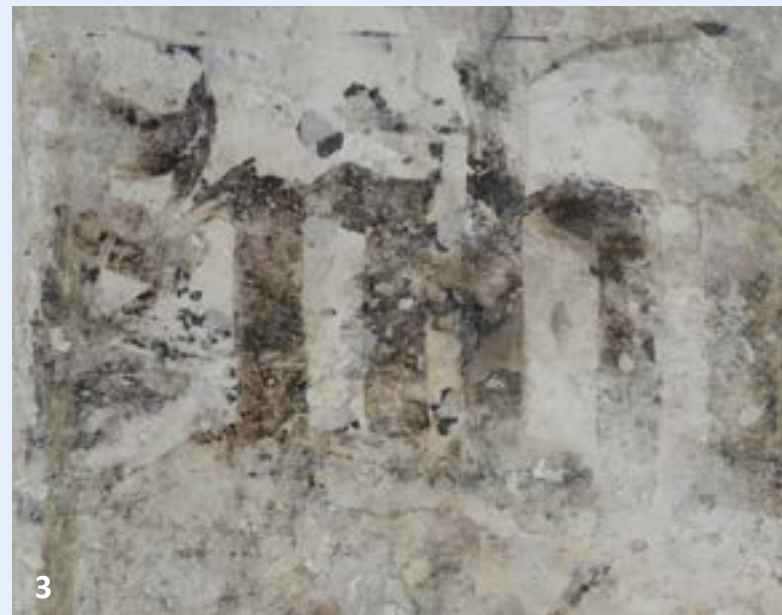
The uncovered 'window' on the south side of the west wall survives as a complicated palimpsest of partially surviving layers (*left*), as further illustrated and explained on page 16. At least three distinct phases of painting can be discerned. An upper white plaster layer, which contains hair, preserves faint traces of black-letter text, probably of C17 date. Unfortunately, no words can be deciphered, but possibly the numerals 3 or 5(?) and 6 (?) are present, which could indicate that this was a quoted Biblical text concluded with the chapter and verse numbers. Also painted on this layer, and therefore probably accompanying the text, are indistinct forms in yellow outlined in black, but what they represent is unclear. Carried over the first black-letter text on a thin limewash are some traces of a later (but very similar) black-letter text, which is even less decipherable, however. A loss in the white plaster in the upper left corner reveals an earlier layer of thin plaster on which traces of red and black paint survive. The date of this layer is unclear, as there is so little evidence to go on.

Details of the different phases of decoration: (1) the earliest layer, showing traces of red and black paint on a thin plaster applied directly over the stone, date uncertain; (2) detail of the two phases of black-letter text. The lower, faint layer may show the number 6. The upper text is applied on a thin limewash layer; (3) another detail showing the superimposition of the text layers. Here, the upper text only survives as very small traces.

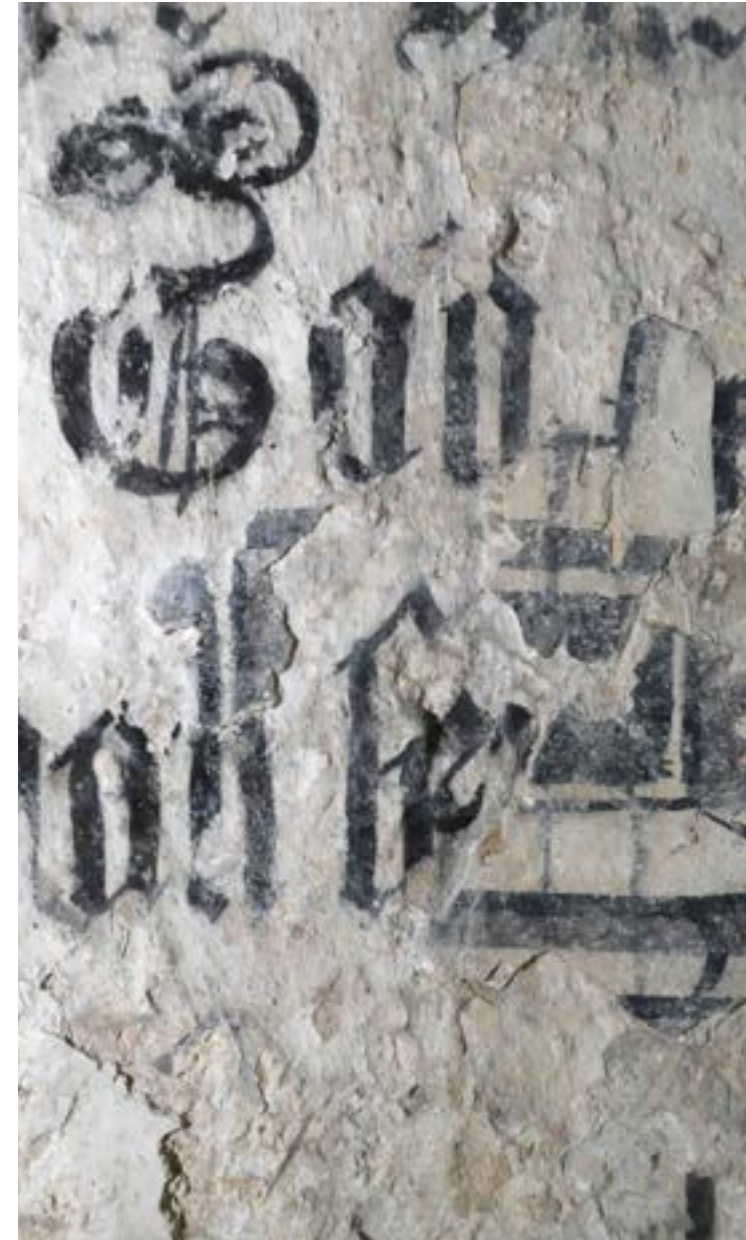
Right: Detail of the text from the Ten Commandments partly obscured by a superimposed fragment of later painting.

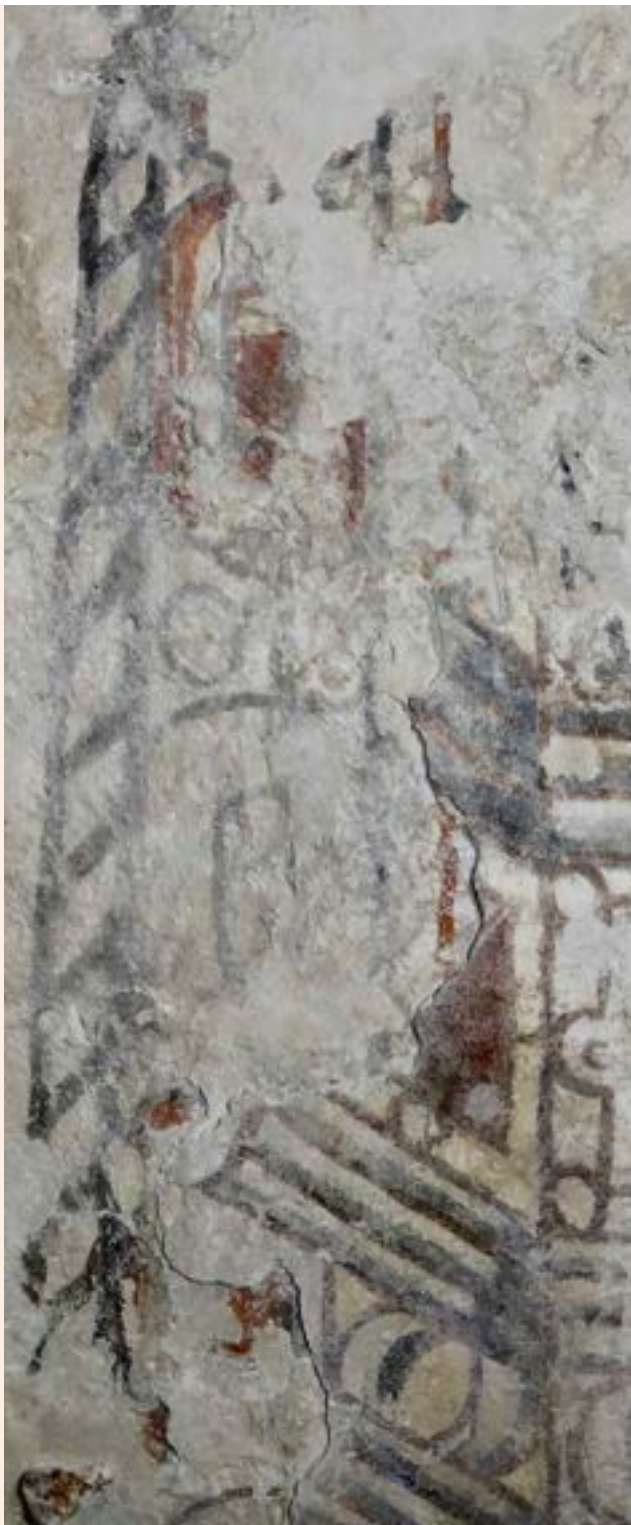
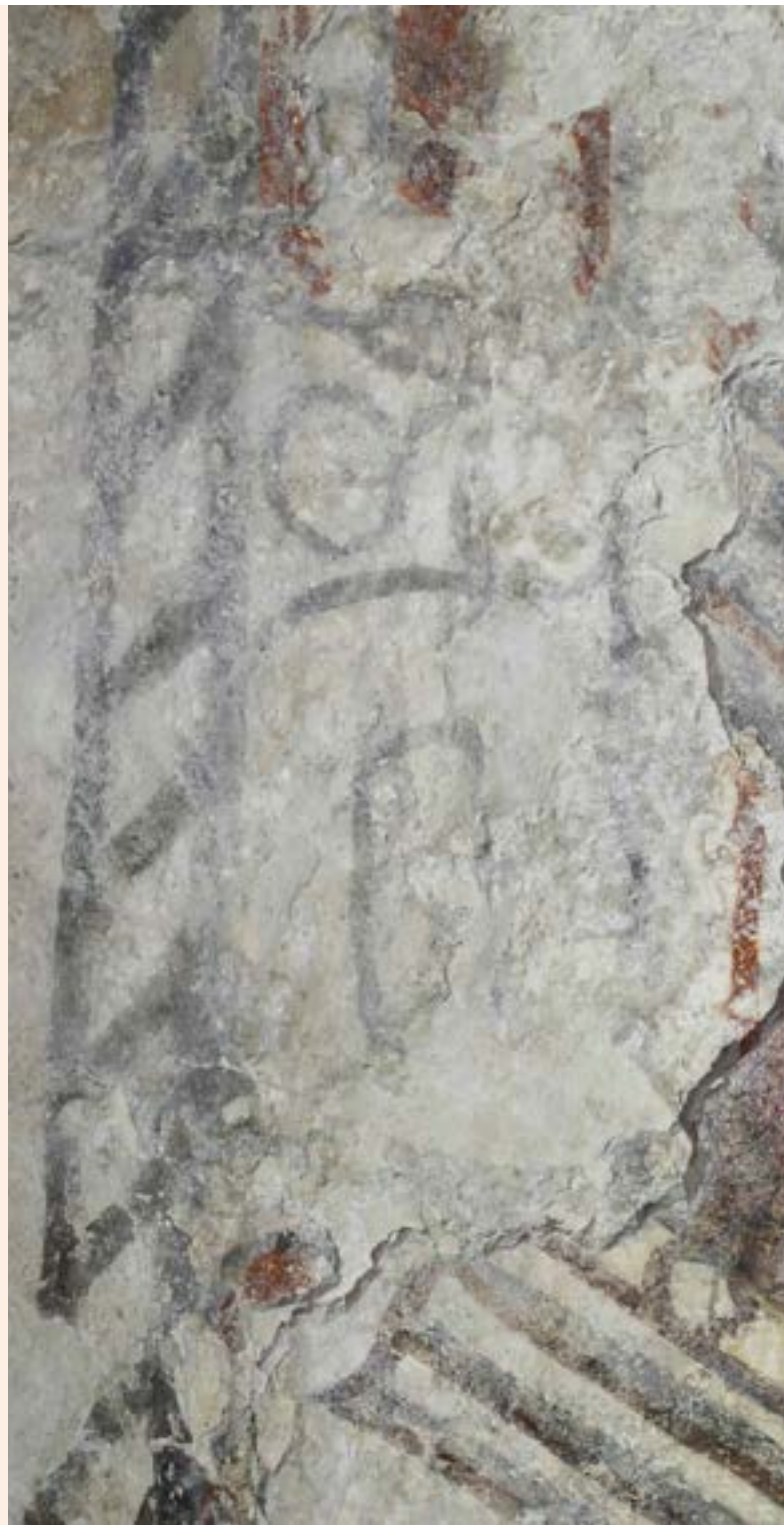
Left: details of the ornamented frame that borders the Ten Commandments. Its width is about 30 cm. A 'twisted rope' design forms the outer edge, while the inner edge is defined by parallel black and red lines. Between these is a 'jewelled' design, a rounded motif which was painted in two alternating colours. Red remains visible but the other colour appears to have faded. Very faint indications of colour appear still to be present on close examination. Each 'jewel' motif was separated by two circles, also painted in the same alternating colours.

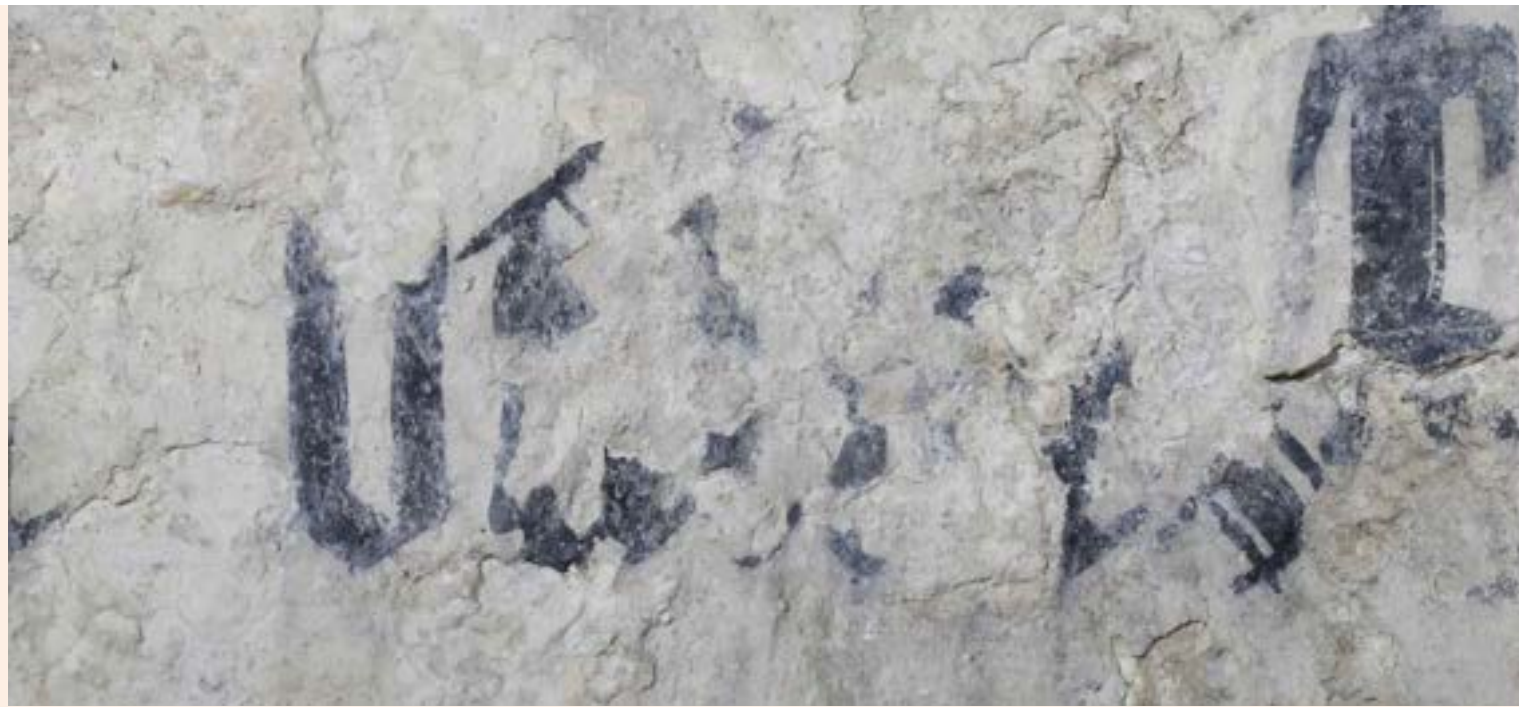
Right: The Commandments are numbered and written out as consecutive sentences. In the exposed area of painting, two distinctive full-stops are visible, one after the final words of Commandment 4 (“... taketh his name in *rain*.”) (top); and one after the final words of Commandment 5 (“... which the Lord thy God giveth *thee*.”) (bottom). After this last full-stop, part of the number 6 is visible, indicating the start of the next precept.

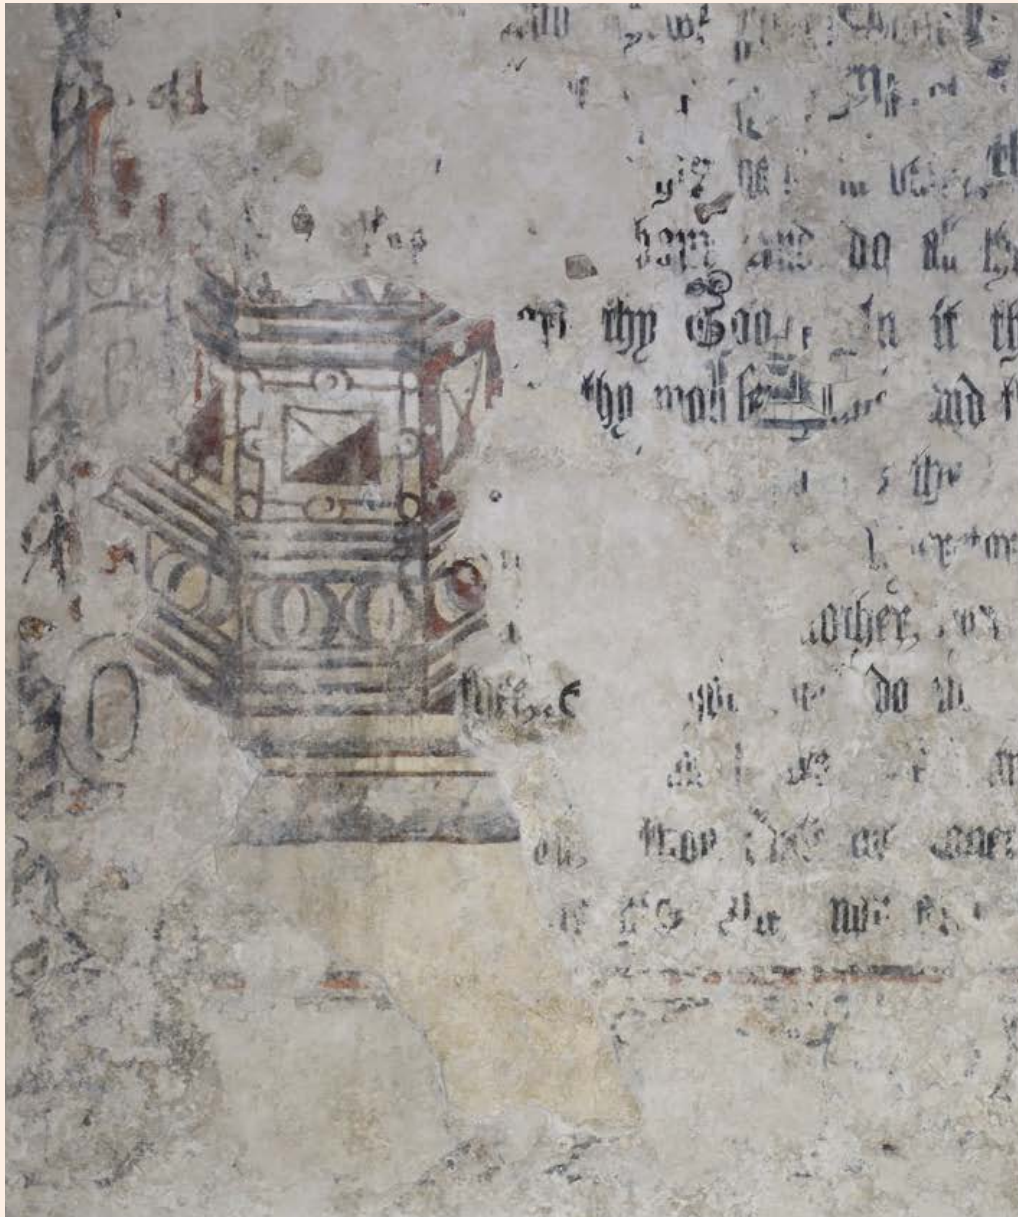
Left: In this transcription of the revealed text, the words shown in red are those that are most legible. This allows adjacent words that are now missing or damaged to be added in their approximate places (indicated in black).

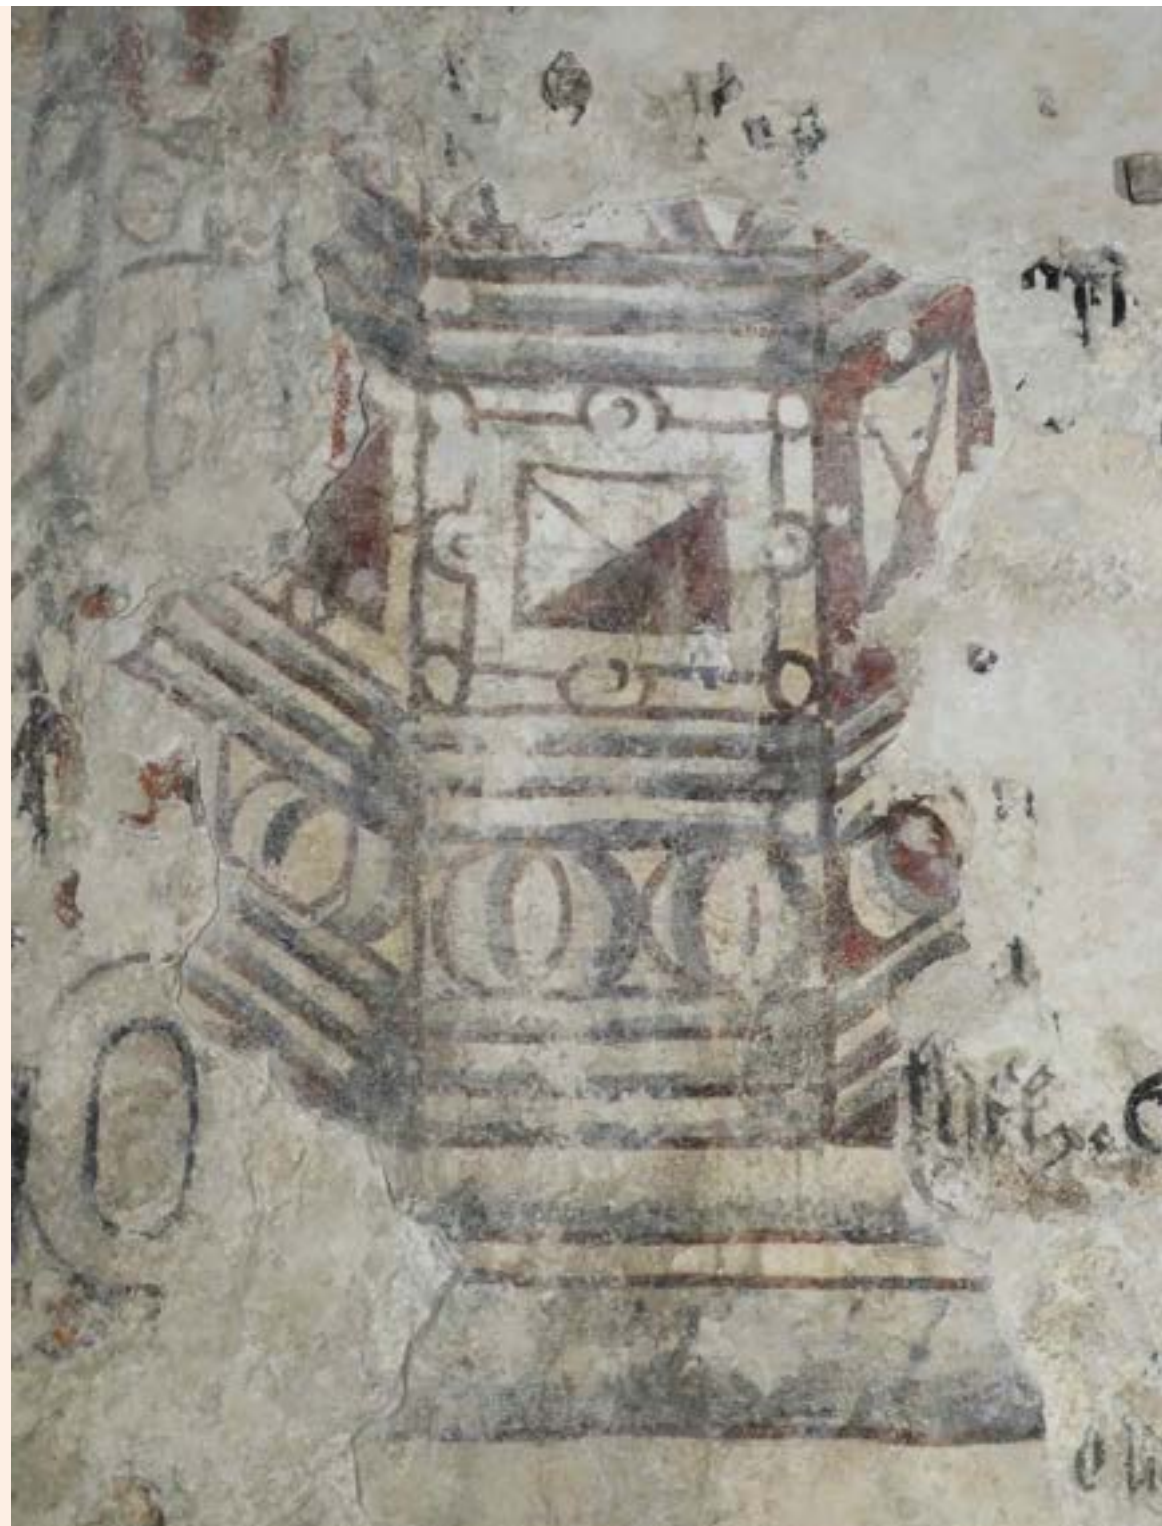
Right: Detail of the 'architectural' fragment which overlies the Ten Commandments.

Despite their differences in style, the 'architectural' painting was probably done not very long after the Ten Commandments. Stylistic trends overlapped and coexisted in this period, and artistic differences between paintings may have had more to do with other factors, such as competing patronage and levels of expenditure, and the availability of skilled painters.

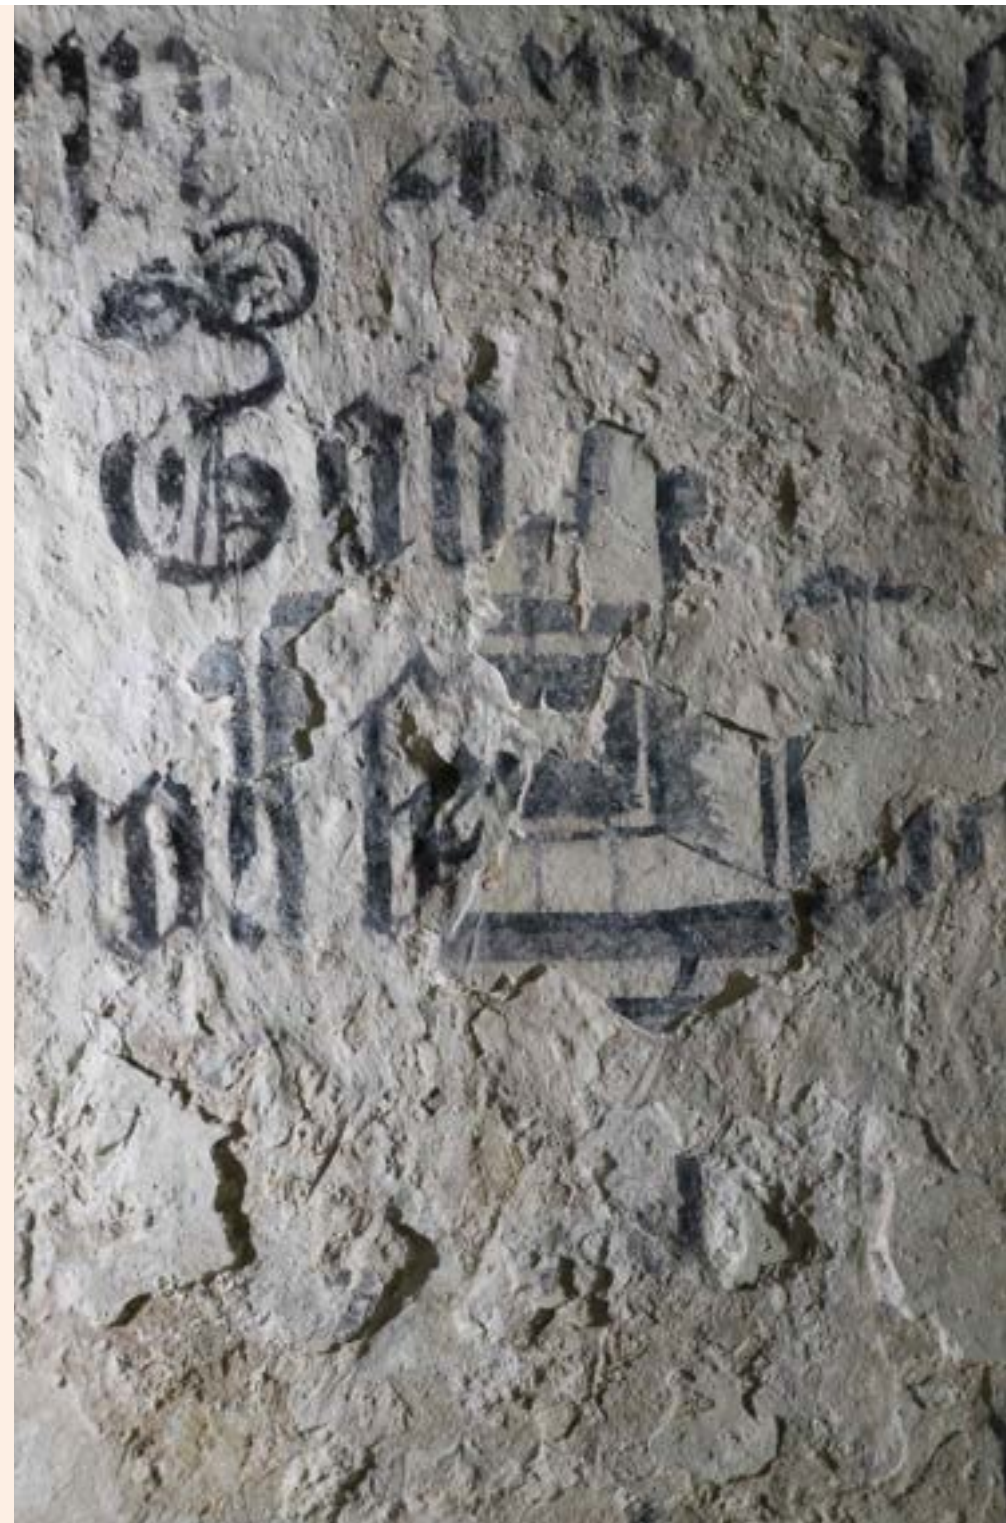
Over the lettering of “... lord thy God ...” from the Fourth Commandment are some fragmentary remains showing a perspectival design painted in black (*right*). In its architectural style and execution on a thin plaster, it has some similarities with the main architectural fragment (page 26). However, it cannot be stated for certain whether they belong to the same phase of decoration. The black design may equally belong to an entirely different phase of painting.

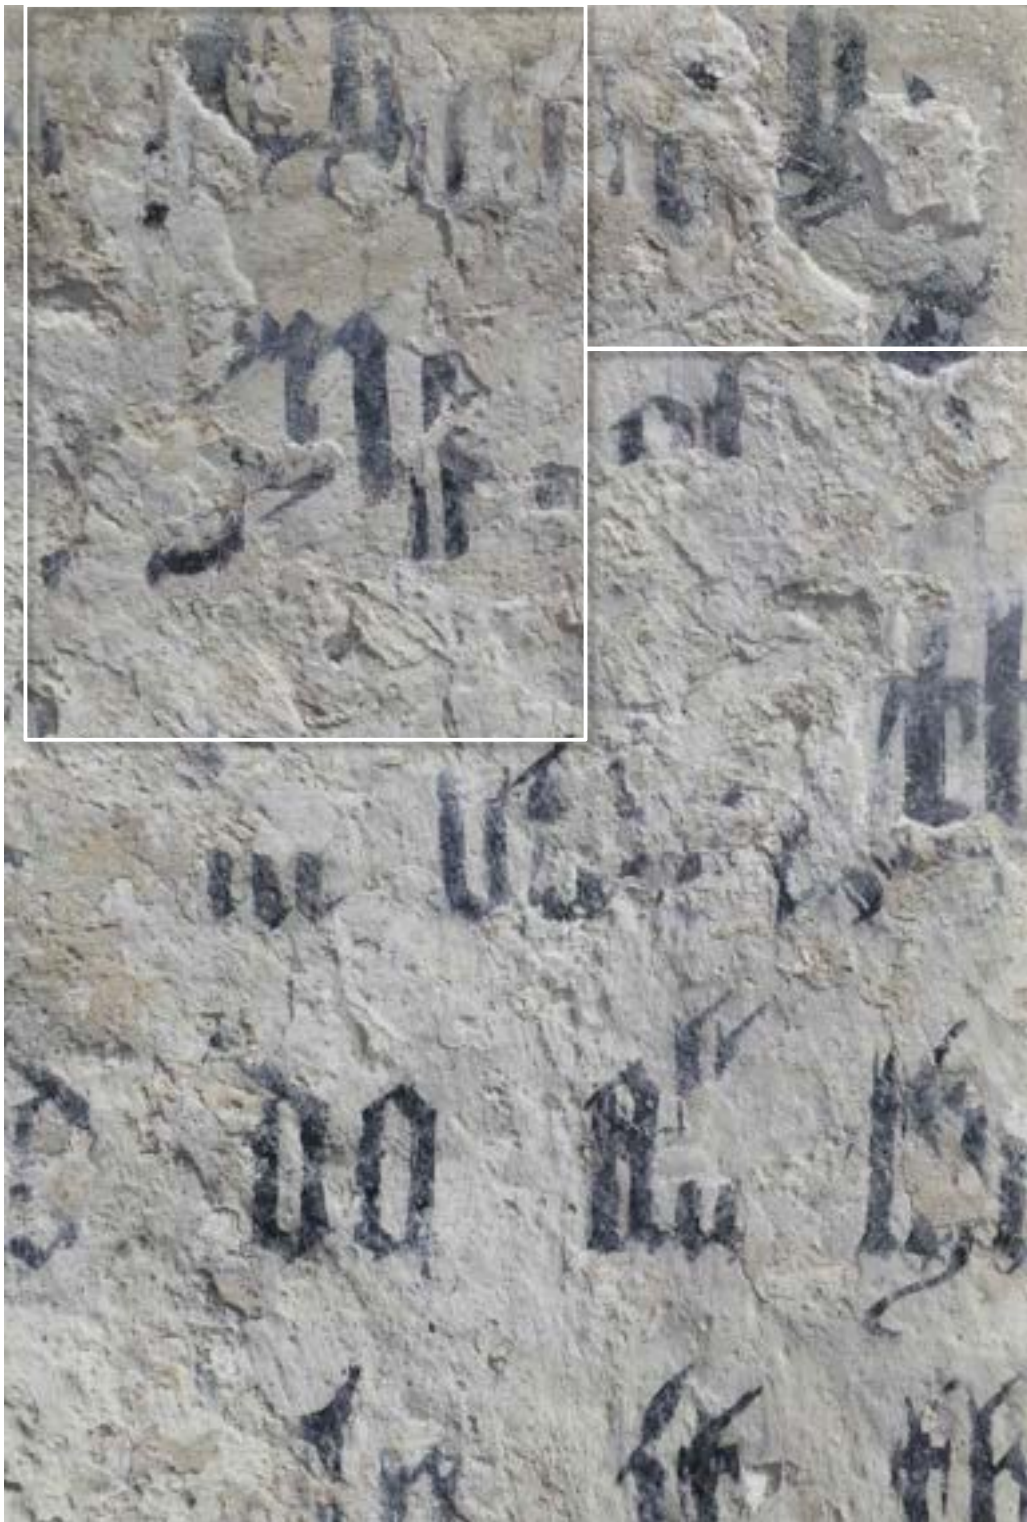
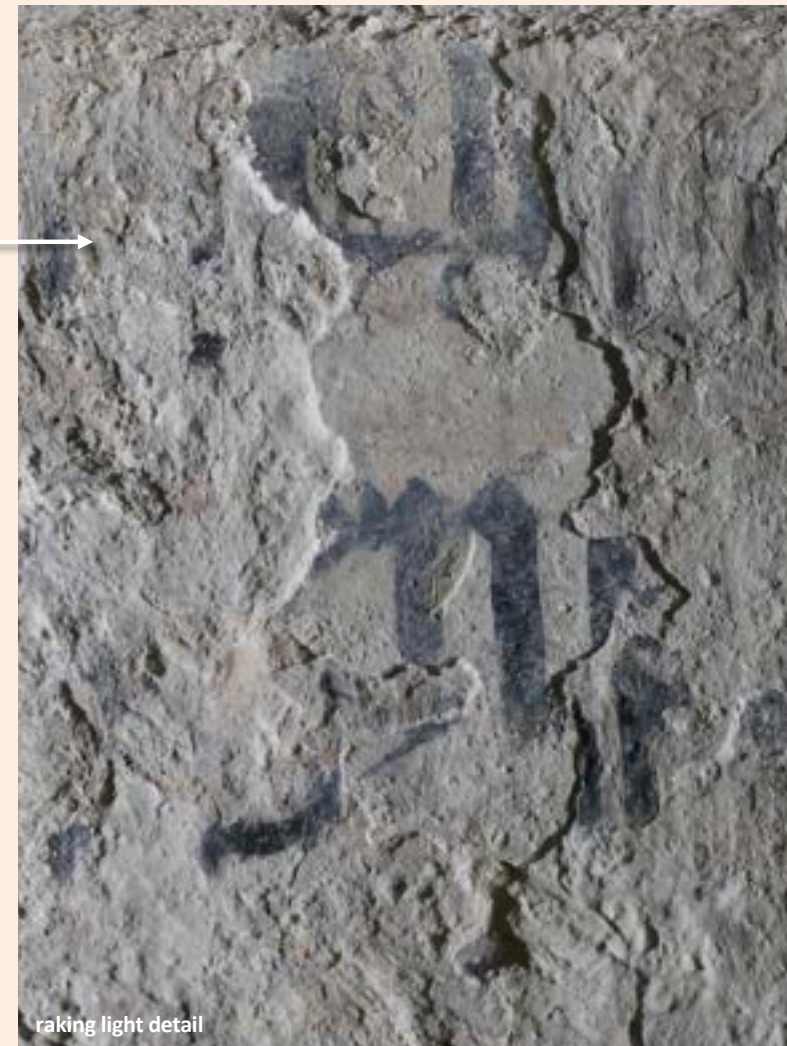
raking light detail

Left and Above: In the top right corner of the currently revealed portion of the Ten Commandments are fragments of another overlying black-letter text, also executed on a thin plaster skim. The lettering is marginally broader and not as finely delineated as that of the underlying Commandments. Once again, it is unclear if this text painting is coeval with or separate from other overlying fragments. No words can be deciphered.

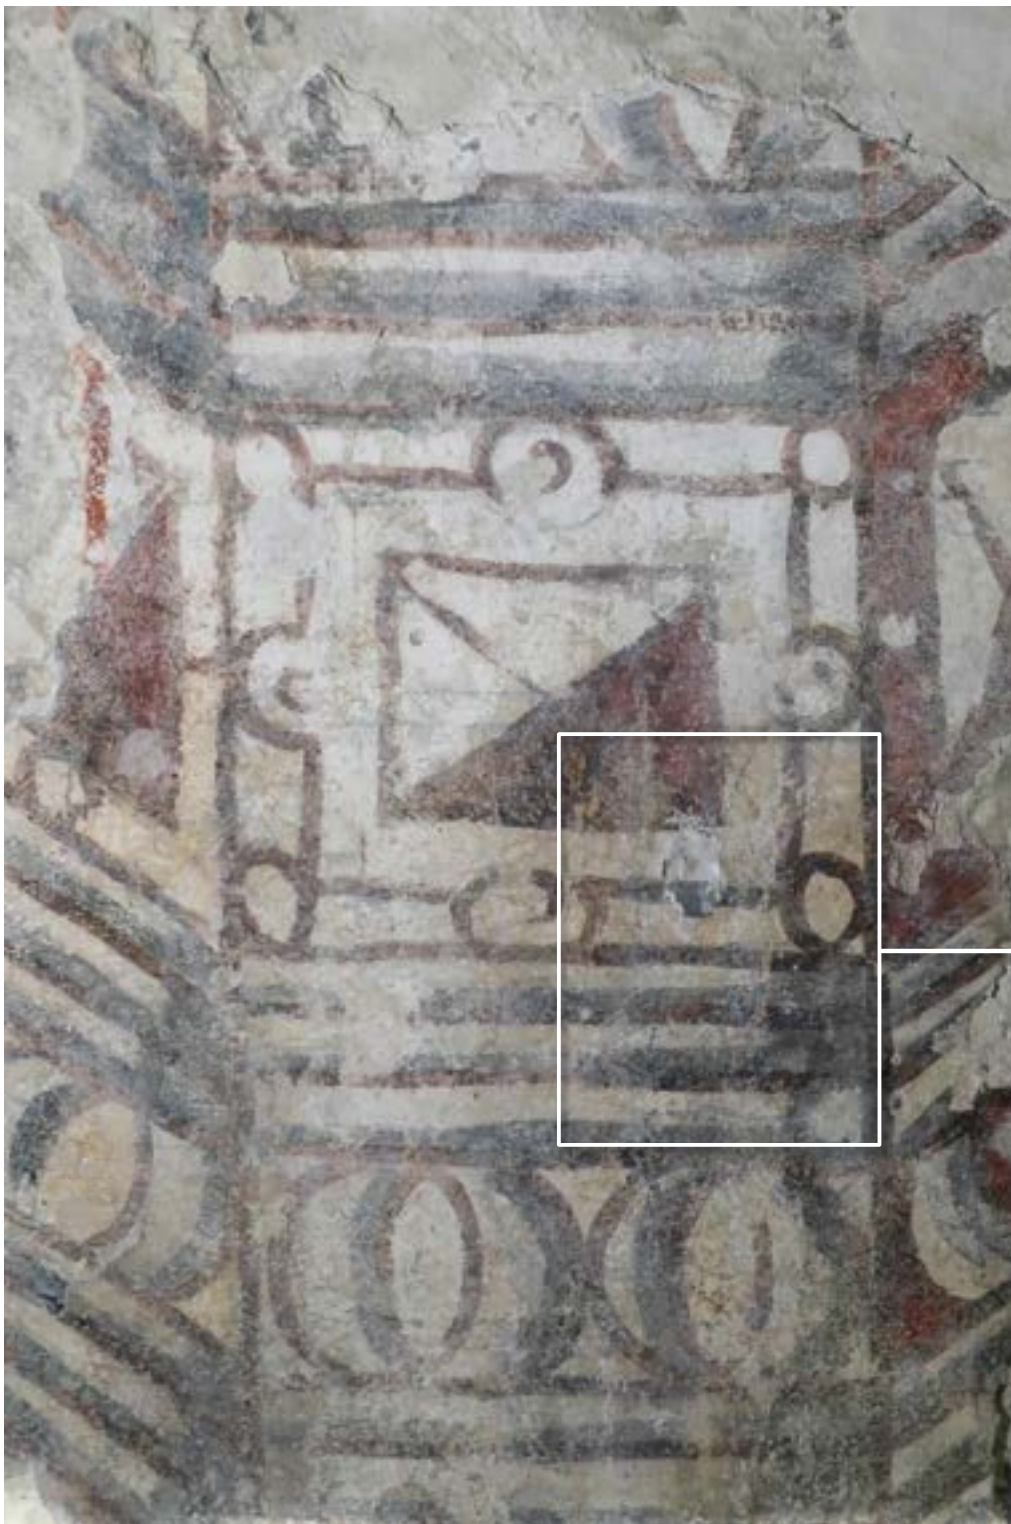
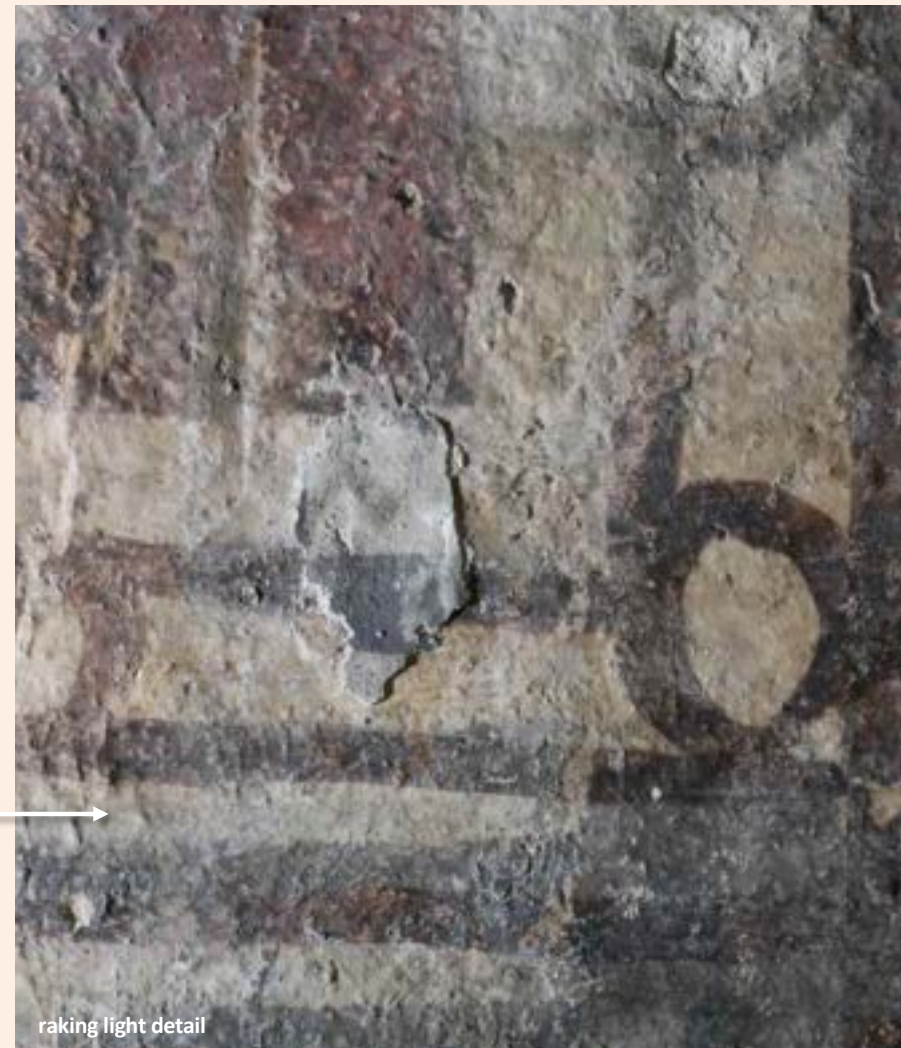
Left and Above: Very small traces of what appears to be a black-letter text painting survive on a limewash layer on top of the architectural fragment.

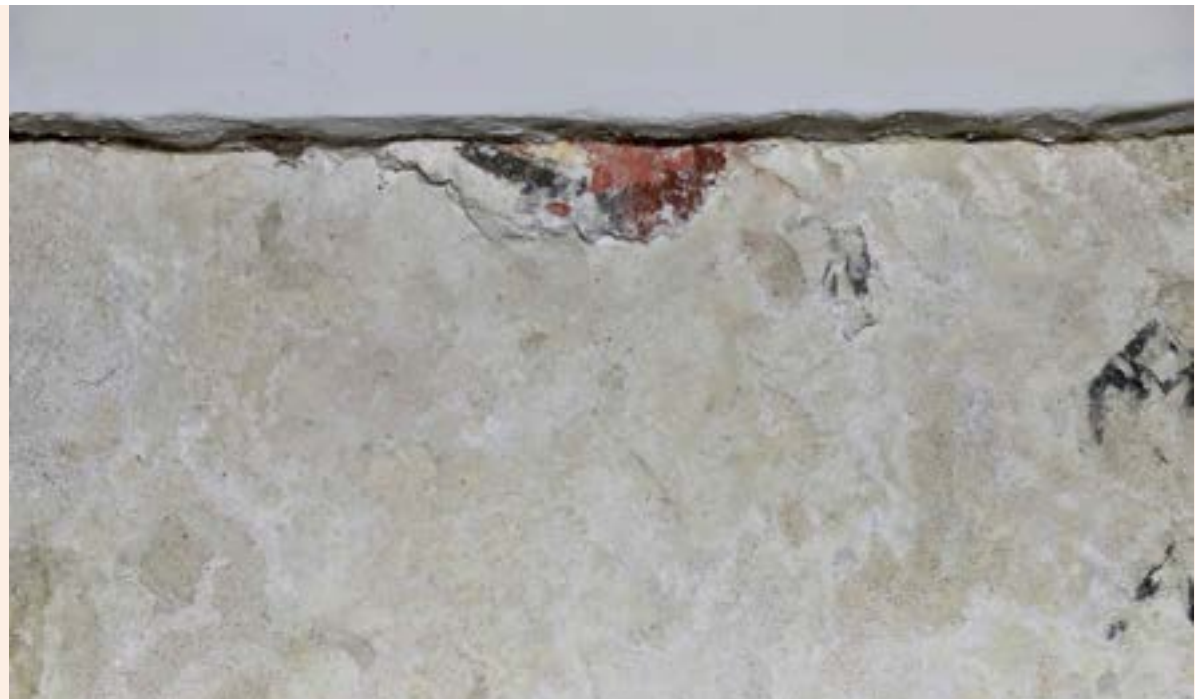
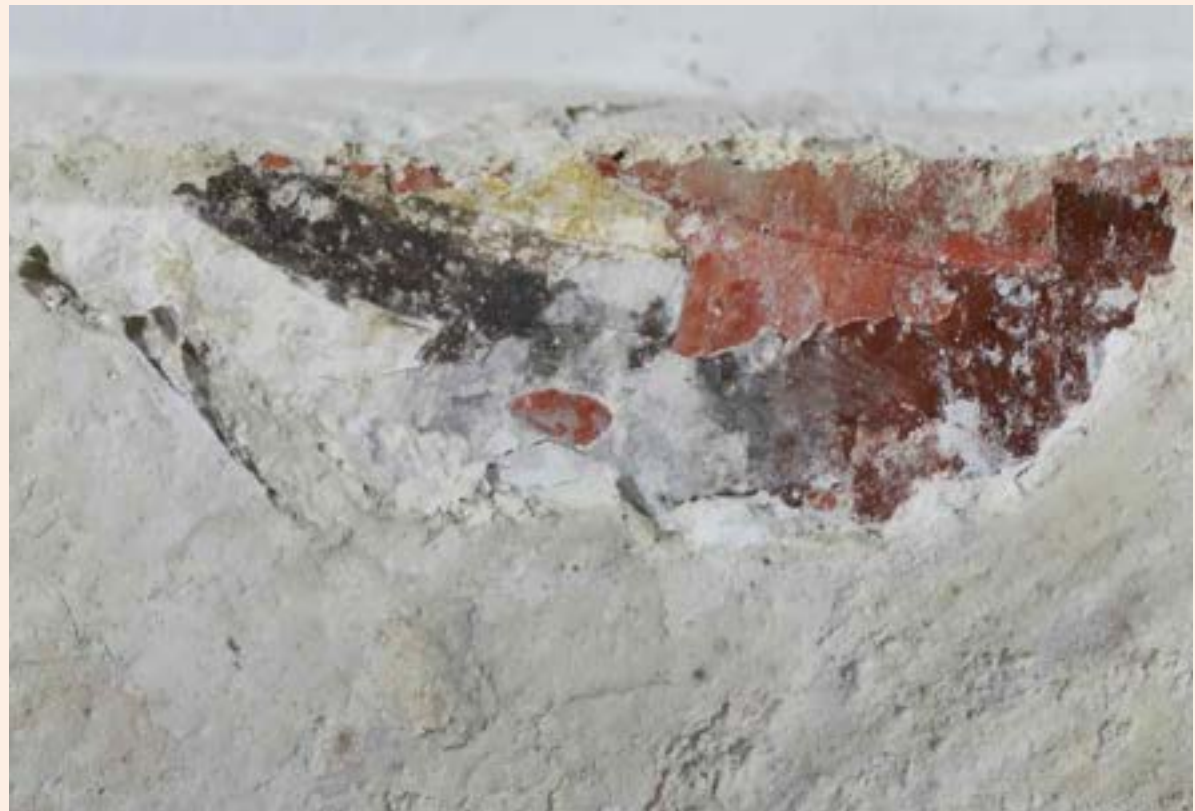
Right: At the top edge of the currently revealed portion of painting is a small fragment of plaster preserving two phases of painted decoration. The lower layer is particularly colourful, showing a design feature painted in black, red and yellow. The deep tone of the red paint resembles that used on the architectural fragment. It therefore seems likely that this phase of painting represents a continuation from the architectural fragment. On a limewash layer applied over this is another phase of painting, only visible here as a brighter red colour. This may be coeval with the traces of black-letter text found on the architectural fragment (see page 32). The survival of this fragment is especially tantalising as it clearly continues further up the wall beneath the covering plasterwork.

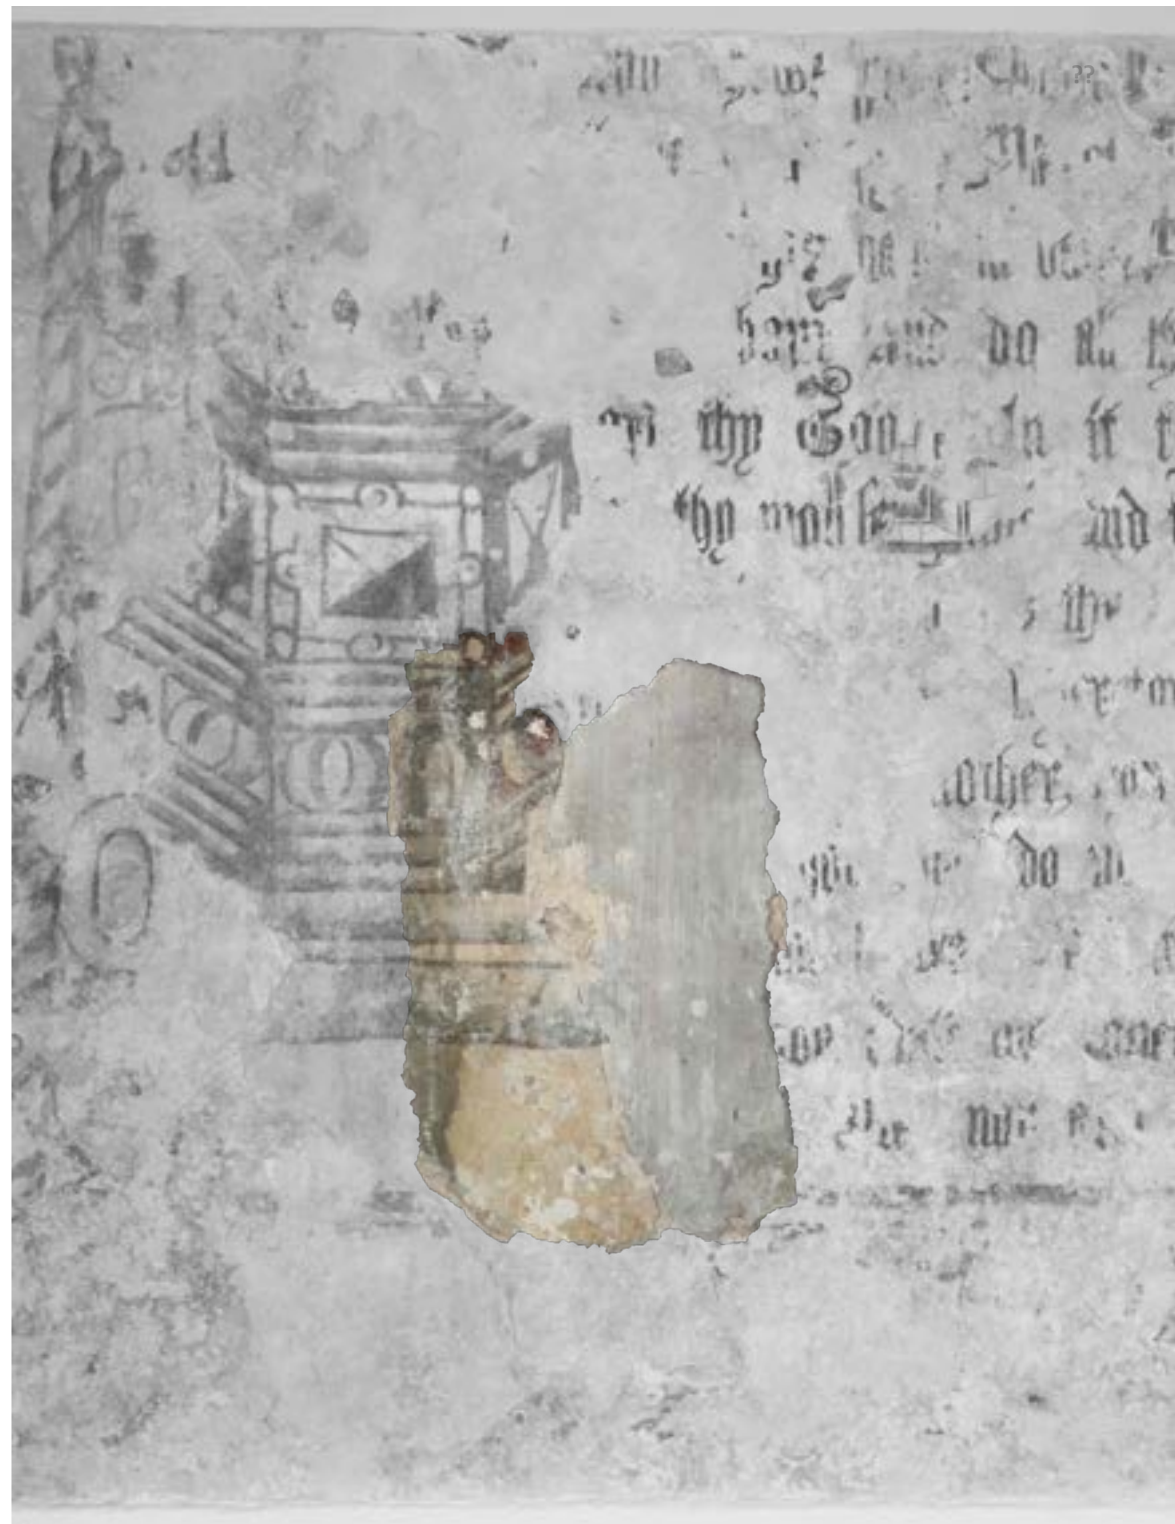
Right: the fragment of painting (in colour) as it was initially exposed superimposed on the recently revealed painting (in greyscale).
